STRATHBOGIE SHIRE COUNCIL

12.2.1 Tree Management – Seven Creeks Park, Euroa Township

***Eucalyptus camaldulensis* (River Red Gum)
Apex Park, Euroa Victoria**

**Visual Tree Inspection Report
for the
Shire of Strathbogie, Victoria,
Australia**

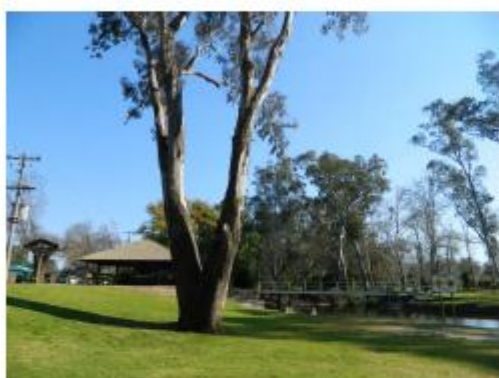
Multi stemmed tree

Due to the formation of this tree I would like to point out the following quotes, 'Multi-stemmed tree stems typically grow away from each other towards the light rather than staying upright by means of tension-wood formation, then their growth in thickness acts like a set of wedges to drive them apart at the base of the stem cluster. This means that the cluster is suicidally programmed to fall apart (Mattheck and Breloer 03).'

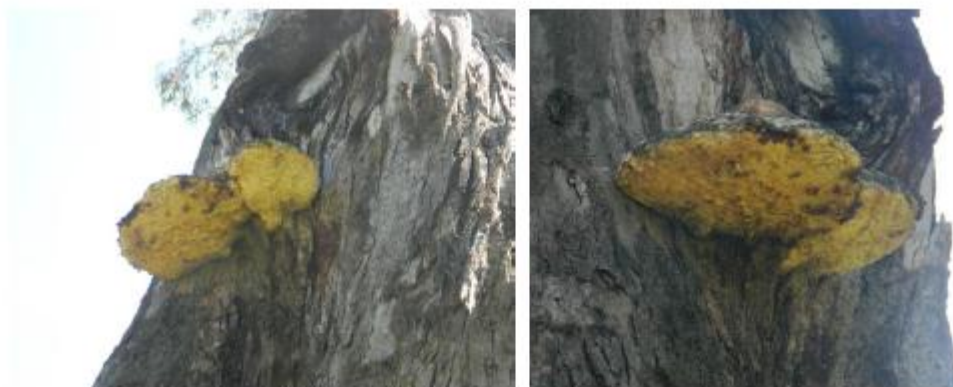
The main scaffolding branch which heads in a northern direction is a major concern as about 4 metres up a wound can clearly be seen. On this wound is a major bracket fungus which will in the future aid in the failure of this tree. More trees fail with bracket fungus than without.

The Fungi will penetrate the timber and destroy the eternal part which is unable to be seen there for the amount of decay would be unknown and unsafe. I have had some research done on the fungi and it would come under the Polyporoid Fungi "Most species of this very large group are involved in the decay of wood, some are destructive tree parasites" (A.M. Young, A Field Guild to the Fungi of Australia, 2005).

This is a clear hazard and it is clear to see that there is major possibility this tree will fail, removing this large branch will unbalance the tree. Pruning this is not an opinion as this is a dangerous scaffolding branch and will fail to the north. I would not allow my children, if I'd known about how dangerous this branch could be, to play under or near this tree.

Following extensive analysis and careful consideration, it is my professional opinion this tree should be removed. To support my recommendation, I summarise the following points:

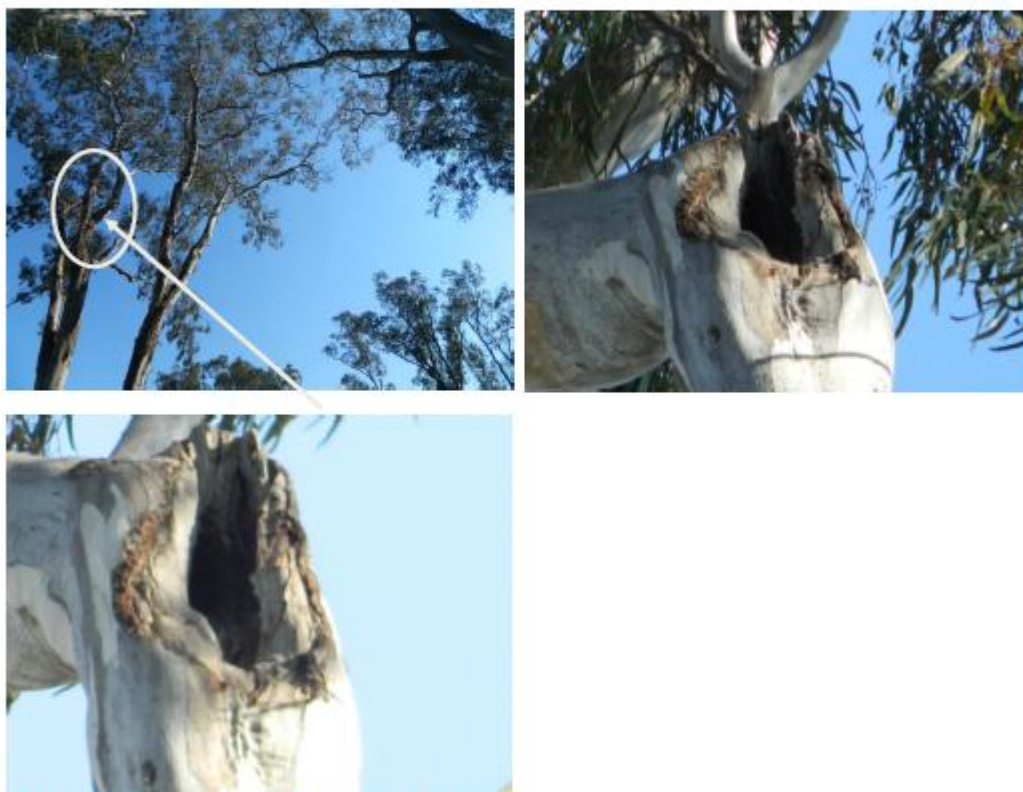
Pictures take at height by climbing the tree

Within in the crown a large number of hollows could be seen, which had compromised the TR Ratio. The area is a concern and holds a large amount of weight above the fault which could fail at any time.

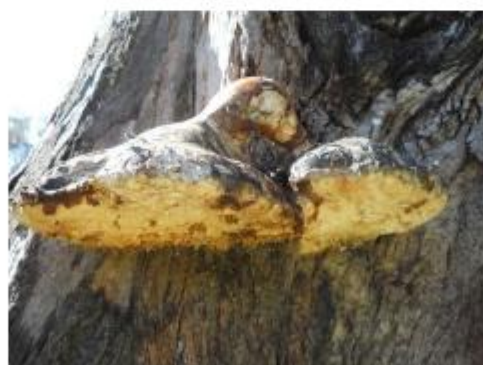
Bracket fungus found on E00058

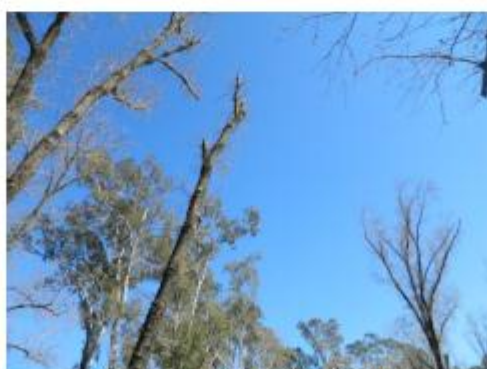
Most of the trees have been pruned in the past and a number appear to have been removed. Some of the pruning has disfigured the trees and the pruning is not to the Australian Standards Pruning of Amenity Trees AS 4373-2007. The pruning is very poor and has caused lions tailed branches as well as epicormic growth (see footnotes). We would like to point out the Standards are not law but they are a guide on how to prune and look after trees.

Trees not pruned to AS 4373-2007

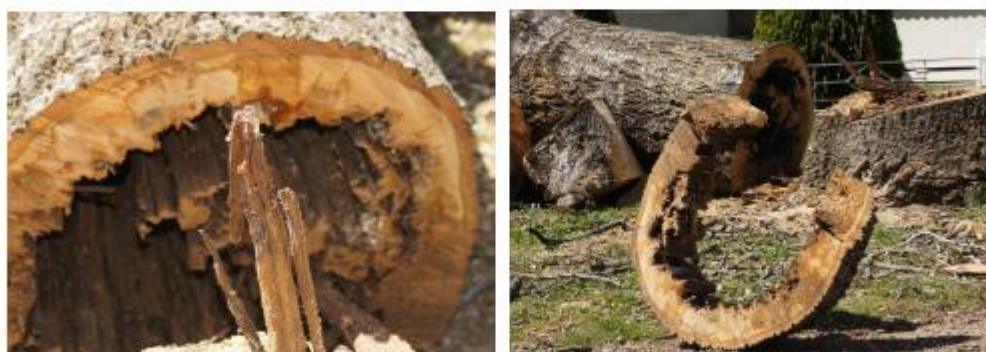
A tree which was removed (from Area 5), which demonstrates a low TR Ratio.

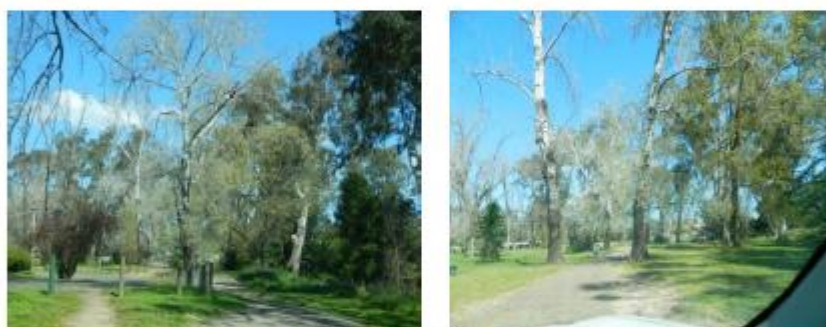
Trees in Area 2 that should be removed and replanted with suggestions below.

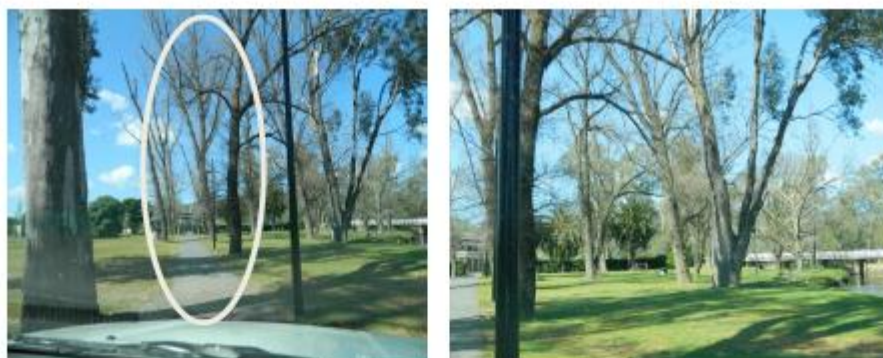
The circled *Populus Canadensis* should be removed. The trees on the right should be left for the time being.

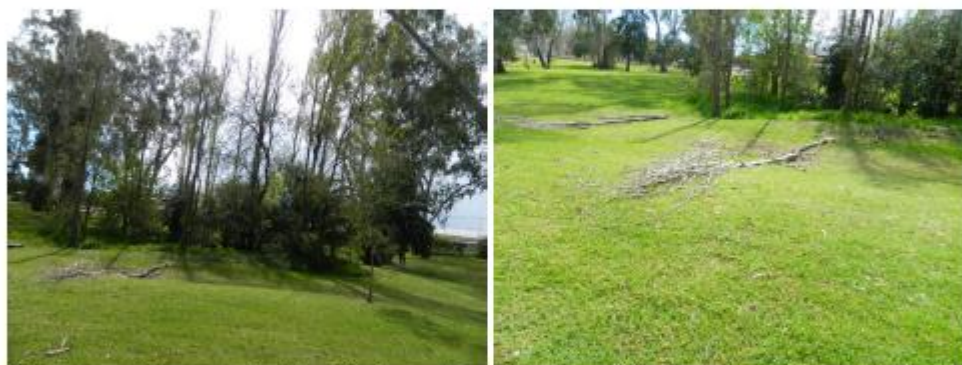
In the middle of the reserve are a number of *Populus sp.* and other various vegetation. A number of the trees have failed and the area provides no amenity value and reduces passive surveillance within the park and this vegetation should be removed. The trees also do not fit in with the characteristics of the reserve and are dangerous. A storm, which occurred on September 19, two trees failed within this area. No one was injured.

This area provides no amenity value and reduces passive surveillance within the park and this vegetation should be removed.

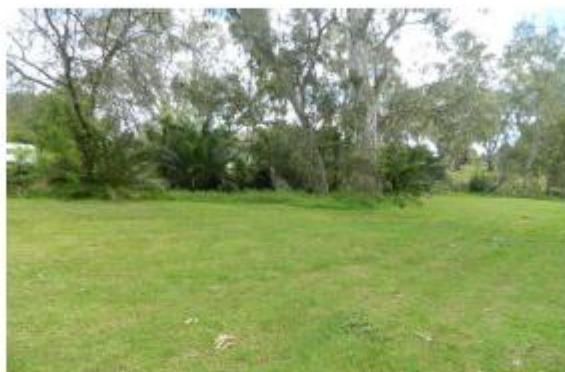
A number of self-seeded *Fraxinus oxycarpa* (Desert Ash) and *Phoenix canariensis* (Canary Island Date Palm) along the creek should be removed.

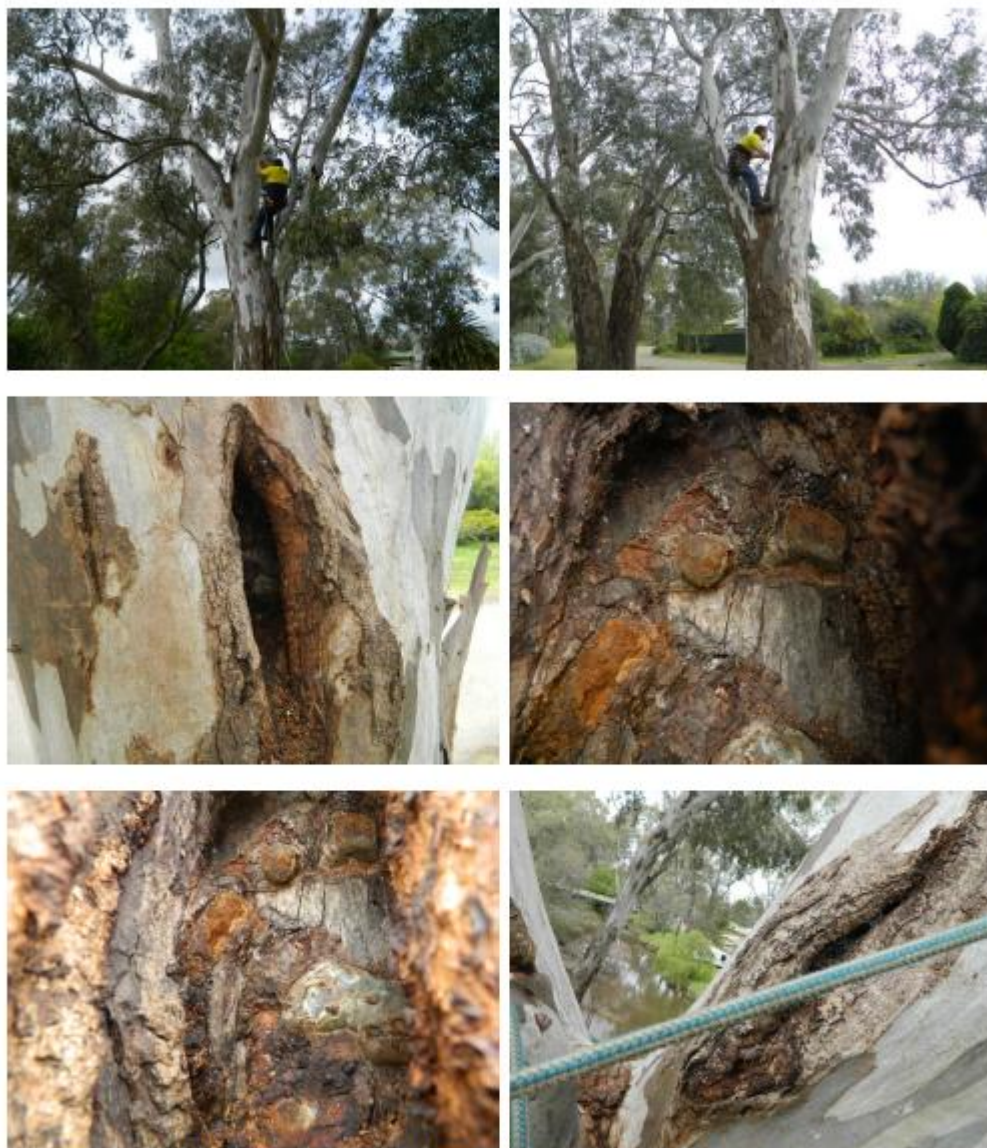
One tree, which is on the north east side of the large reserve (tree number E243), was climbed and a major hollow was investigated and has *Phellinus* fungus growing. This tree is hollow and was proven to council staff to be hollow and will become more dangerous in the future. Also refer to the photo below.

Tree number E243 was climbed and a major hollow was investigated and has *Phellinus* fungus growing.

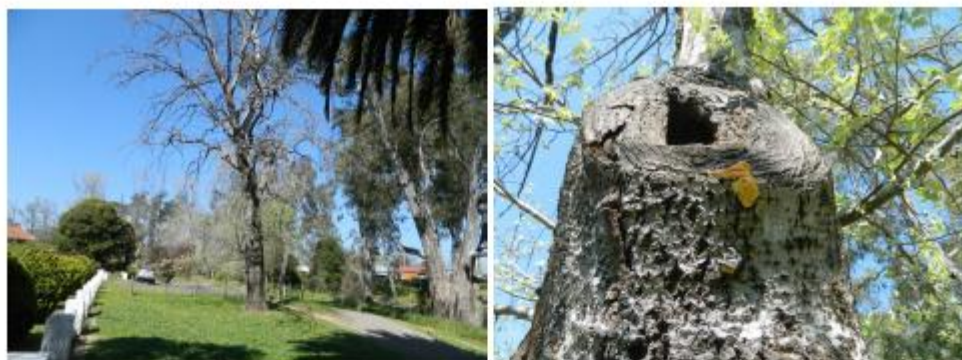
A number of the *Populus alba* (White Poplar) are a major concern and one is completely hollow and it was removed as a matter of urgency due to major safety risks (see photo below). The *Populus alba* (White Poplar) are on the footpath towards Apex Park reserve. We are of the opinion that they should be removed due to the high volume of human traffic. The overall condition of this area is good apart from the above recommendation and the spread sheet.

Populus alba (White Poplar) (Tree E295) emergency removal

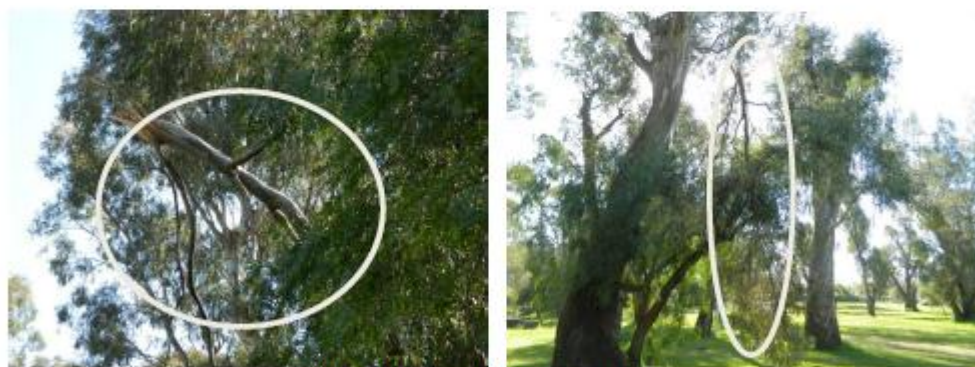
The final area is north of the Caravan Park (the overflow for the Caravan Park). This has the majority of the high risk trees as most have been pollarded in the past. This practice is very poor and dangerous. While we were inspecting the trees two large branches failed, one of which was more than 5 metres in length, it is our opinion that more branches will fail in the future.

Epicormic branches failed in the pollarded trees.

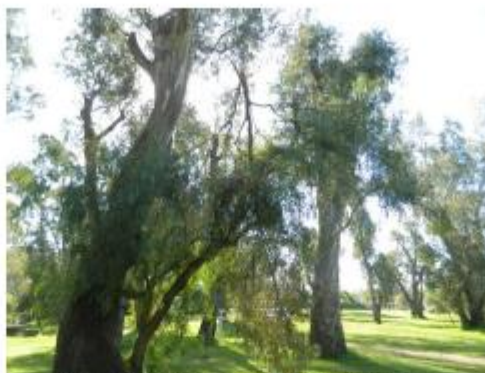
The history of the pollarding is the trees may have been pollarded about 15 years ago and again about 18 months ago. This practice should stop.

An example of the pollarded trees in the area.

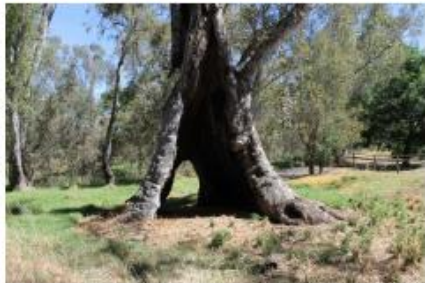
Plate 1: Tree exhibiting remaining structure and ground attachment

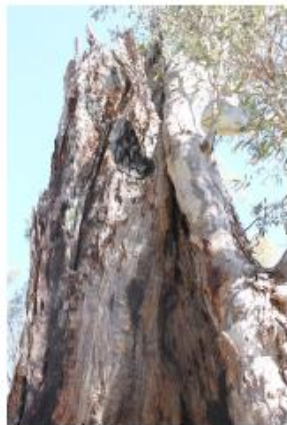
Plate 5: Failed plate resting against callus bulge close frame view ▲.

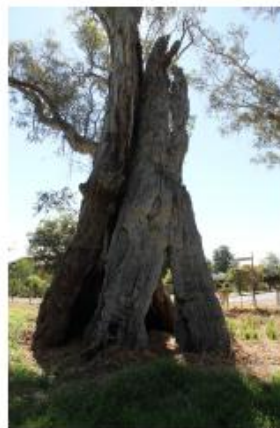
Plate 6: View of dead shell resting against cavity ►.
