Goulburn Street School Crossing Existing Conditions Road Safety Audit

Prepared for Strathbogie Shire Council

10 September 2023

Reference J388O530/0923

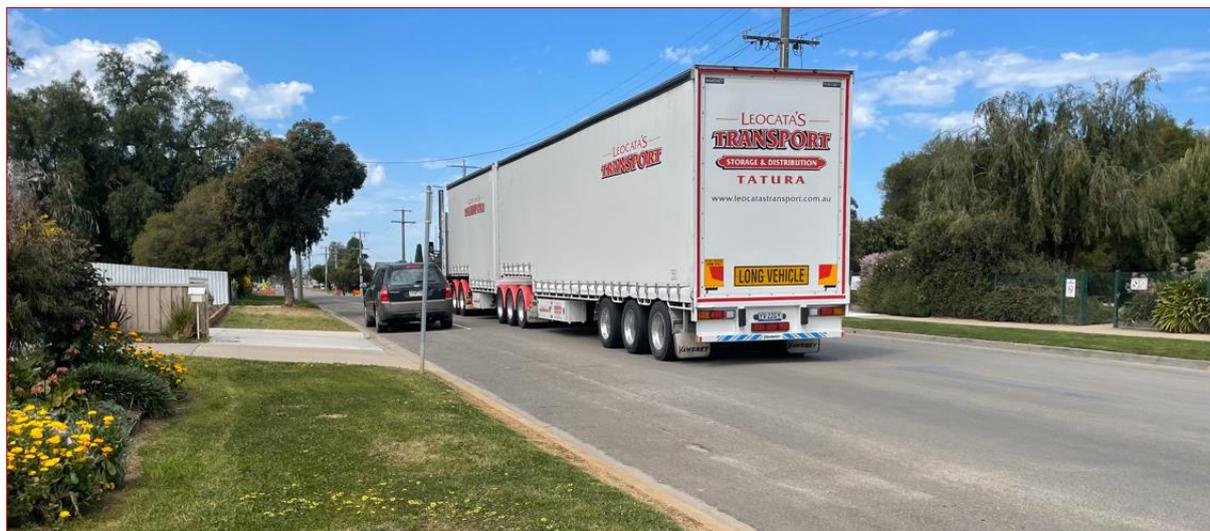
FIGURE 5: HEAVY VEHICLES ON GOULBURN STREET (DUE TO INDUSTRIAL LAND USES)

- A notable number heavy vehicles were observed to be travelling on Goulburn Street through the site, some related to the construction site at the eastern end of Goulburn Street while some originating from industrial land uses. Figure 5 & 6 demonstrate such heavy vehicles observed on site.

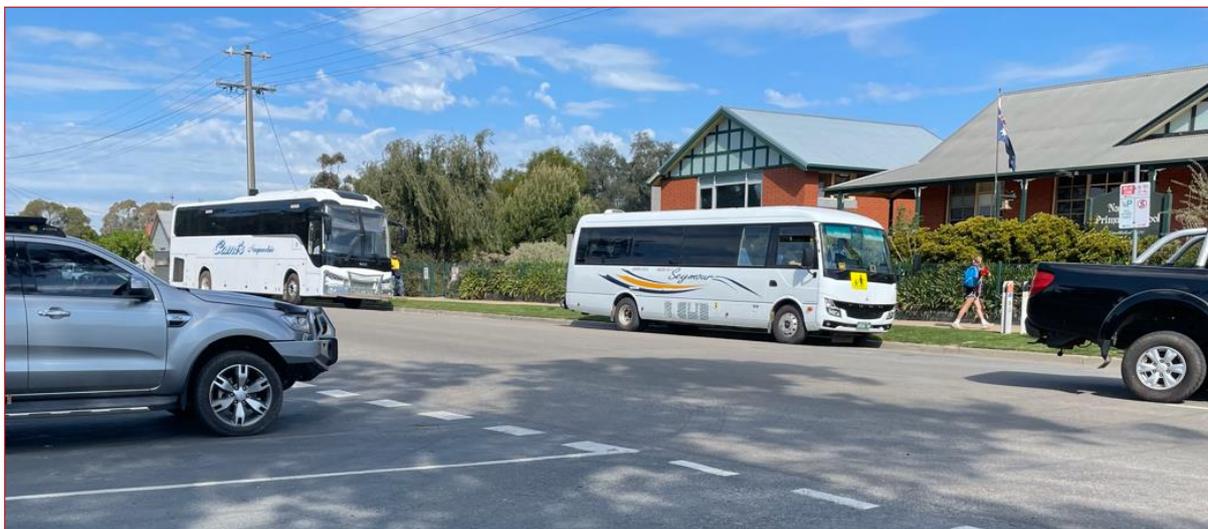
FIGURE 7: SCHOOL BUSES PARKED NEAR THE PRIMARY SCHOOL

- School buses were observed to be parking on the southern side of Goulburn Street. Thus, children *hopping on* these buses were not required to engage in any crossing movements.

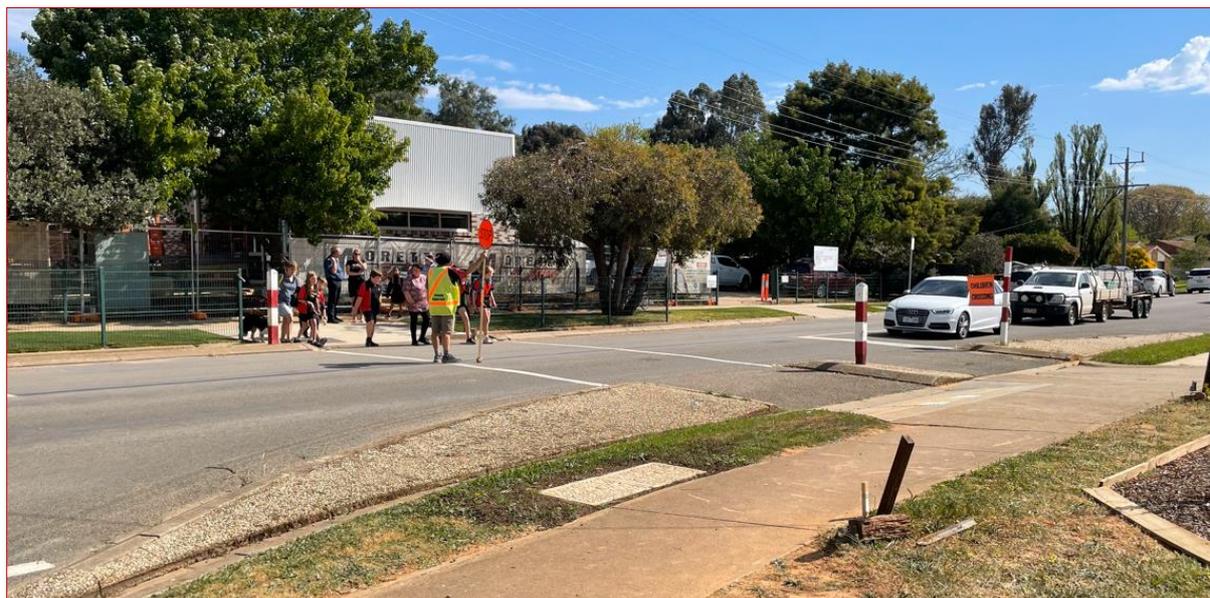
FIGURE 8: OPERATION OF THE CROSSING DURING SCHOOL TIMES

- School crossing was managed by *an adult* with appropriate hand-held sign controls (R3-3) and high visibility clothing. Vehicles were observed to be complying with the instructions provided by the crossing supervisor.

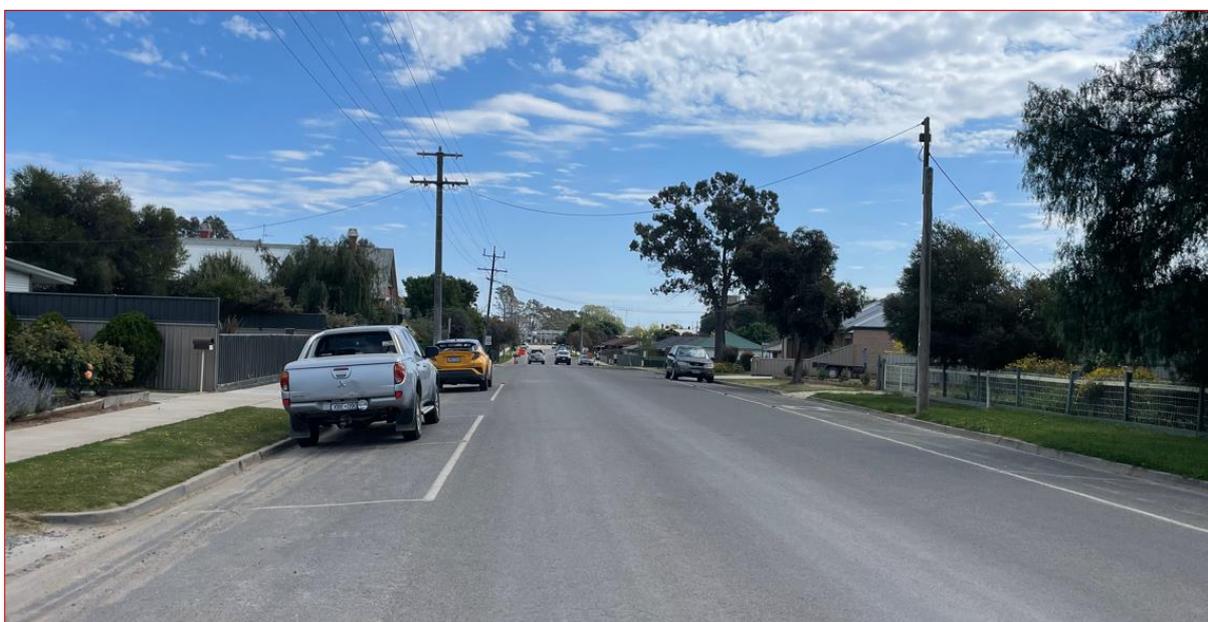
FIGURE 9: GOULBURN STREET

Goulburn Street is a Strathbogie Shire Council owned and managed municipal road oriented generally in an east-west alignment. The sealed road with a 12.5m wide trafficable width connects with High Street (an arterial road) on the west and provides access to a number of residential properties. Footpaths were found to be available on both sides of Goulburn Street and a posted limit of 40km/h was seen near the audit site. However no LATM treatments were observed to be in place to reduce vehicular speeds.

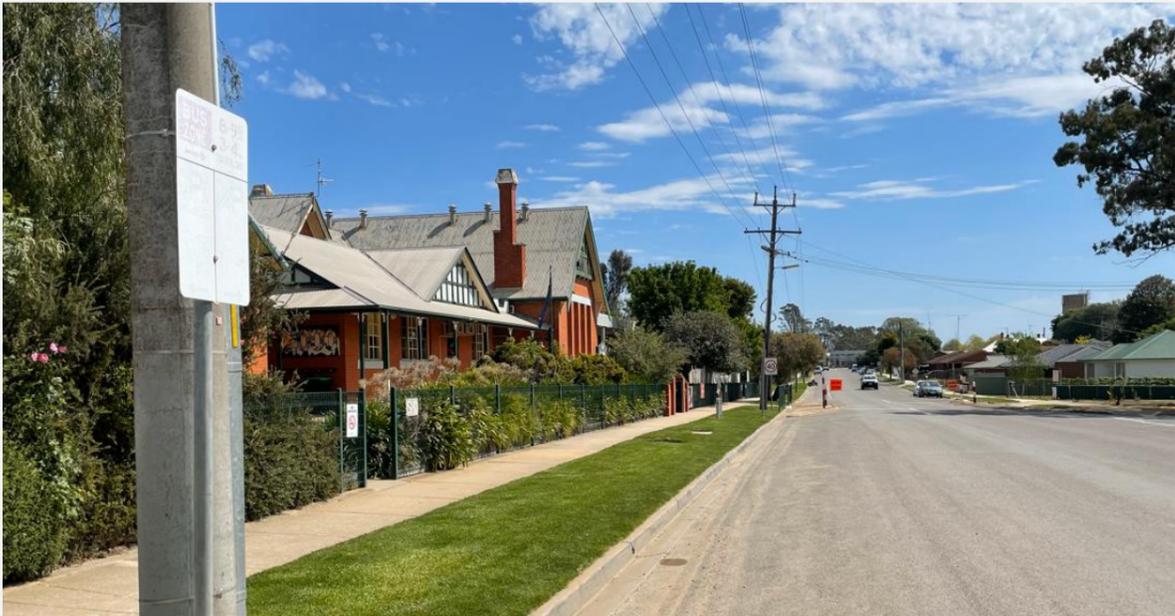
NO	FINDINGS	LEVEL OF RISK (INC. FSI)	SAFE SYSTEM ENERGY	Recommendations <ul style="list-style-type: none"> • Primary (P) • Supporting (S) 	Responsible Officer	
					Accept - Yes/No	Comments
1	<p>Several signs near the Subject Site were observed to be faded and are required to be replaced by new signs.</p>

Noted.	N/A	Sign replacement to be considered (S).		
2	Tactile Ground Surface Indicator (TGSI) treatment currently installed at the crossing were found to be inconsistent and in poor shape.	<p>Likelihood: Unlikely Severity: Serious HIGH (FSI)</p>	Above Tolerable Limits	Consider reviewing the TGSI treatment and making appropriate modifications to achieve compliance (S).

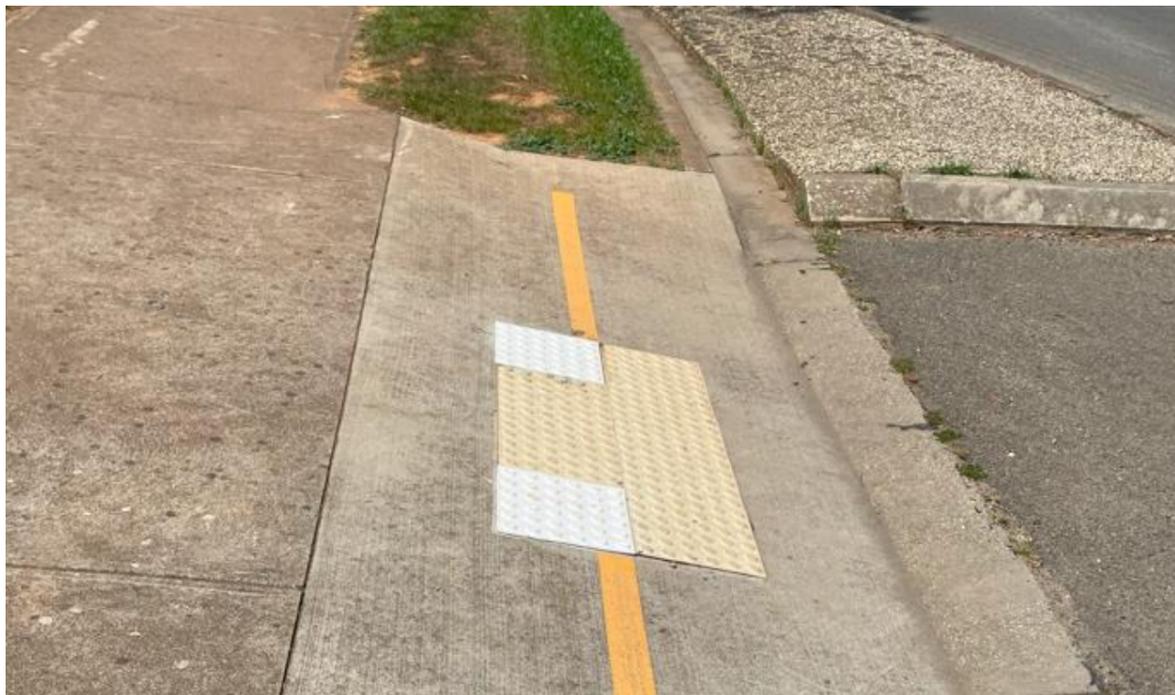
It is recommended that the TGSIs are installed covering the “full width of the path of travel - perpendicular to the direction of travel”. Incorrectly installed TGSIs could lead to vehicle/pedestrian crashes.

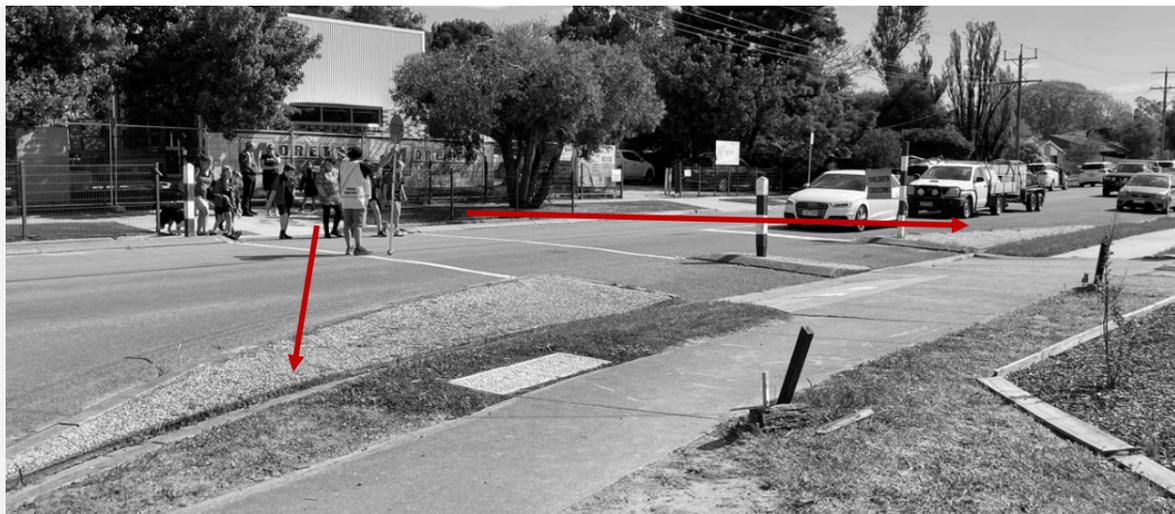
3 A pedestrian containment fence is found on the southern side of Goulburn Street at the crossing which assists in funnelling children (& other pedestrians) towards the appropriate crossing point. Those who were about to cross *from the school* were seen to be gathering at the opening of this containment fence (which only as wide as the crossing itself) and is noted as a positive outcome.

As the users step on to the crossing, they are not encouraged to walk in a straight line as the *desire lines* were often found to be towards the parked cars on Boyd Street & Goulburn Street. The auditors have not captured photos of this behaviour; yet the users were observed to be crossing in the angles indicated by the red arrows in the image below.

Likelihood: Unlikely
Severity: Serious
HIGH (FSI)

Above Tolerable Limits

Consider installing a similar containment fence on the northern side of the road to improving user compliance (S).

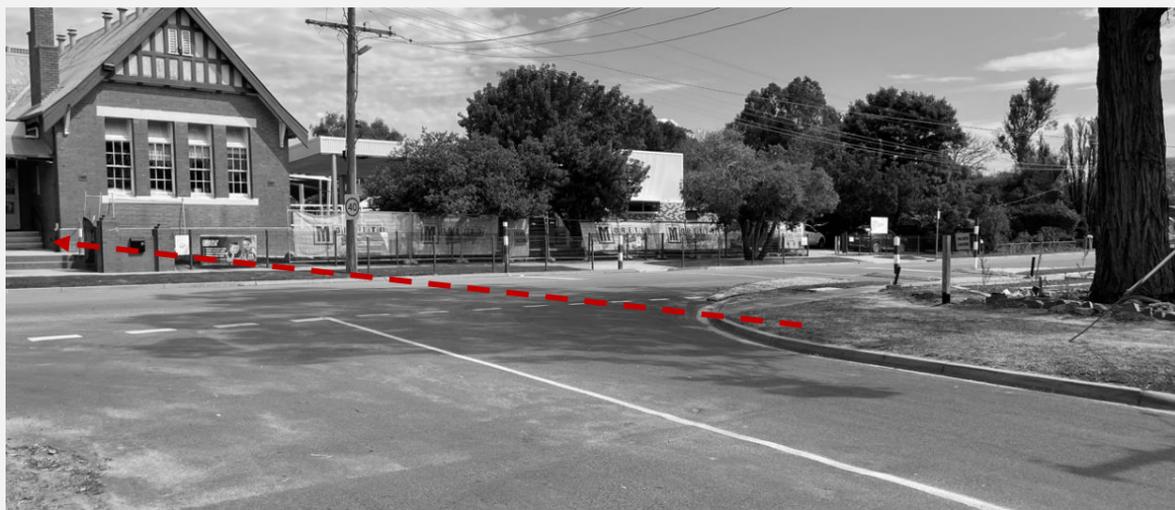
As a result, they were required to step over the level differences created by the kerb extensions found at the intersection of Goulburn Street and Boyd Street. This could potentially give rise to a tripping incident.

This is particularly important in the morning as the pedestrian desire line (shown via dashed red arrow) of those using the crossing are between the northern side of Goulburn (and Boyd Street) towards the main gate of the school.

It is important to have pedestrians use the appropriate area allocated for the crossing movement.

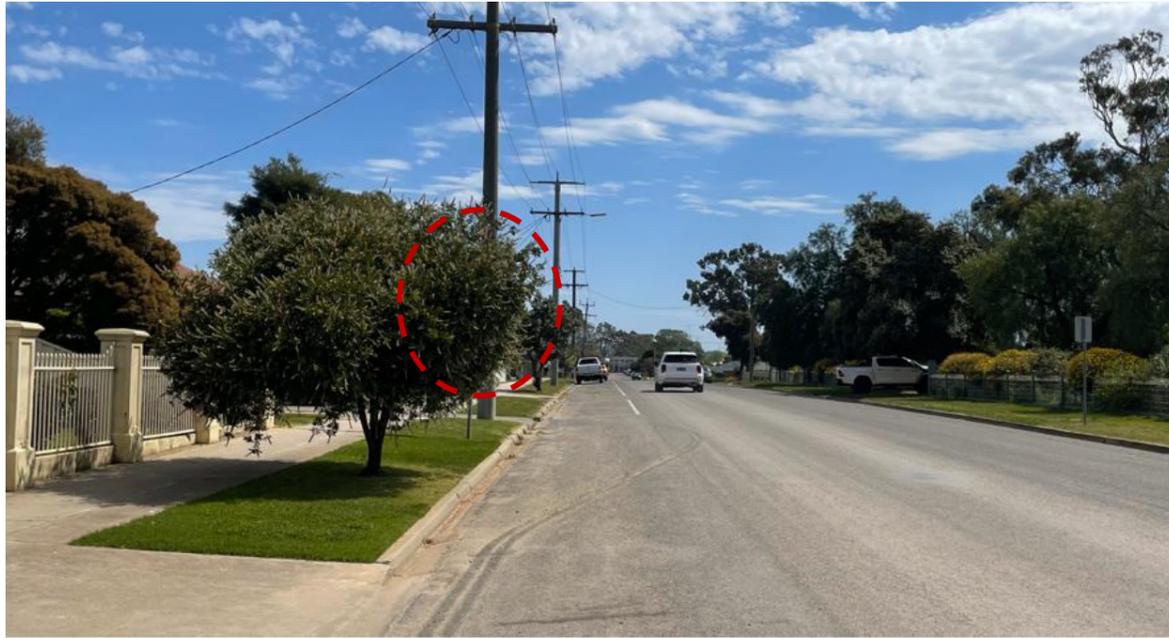
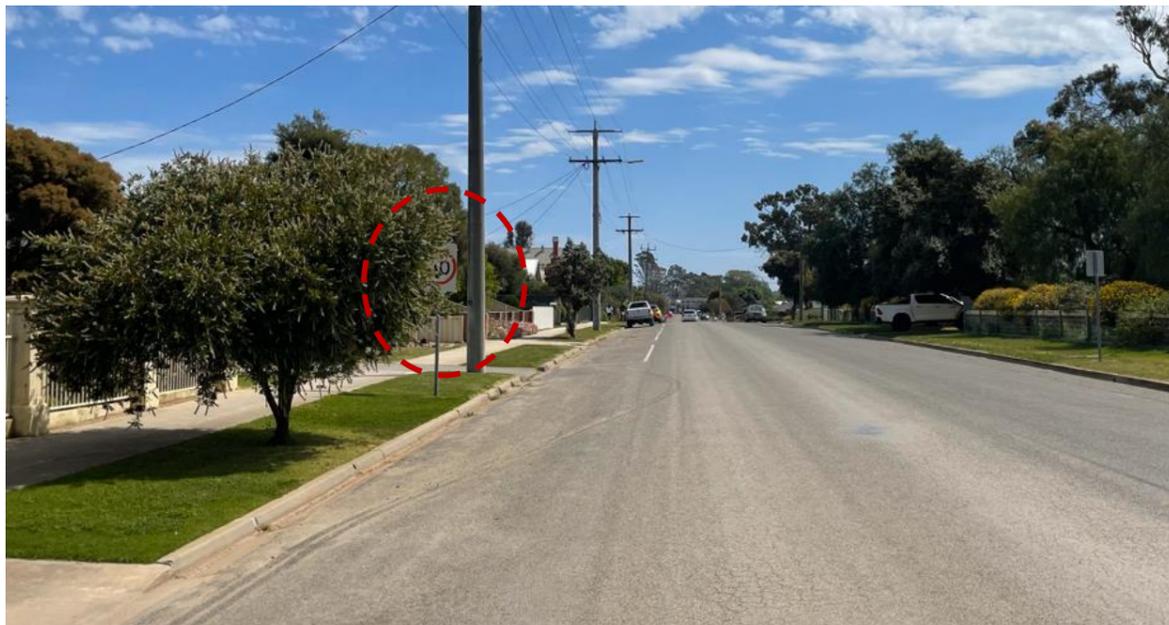
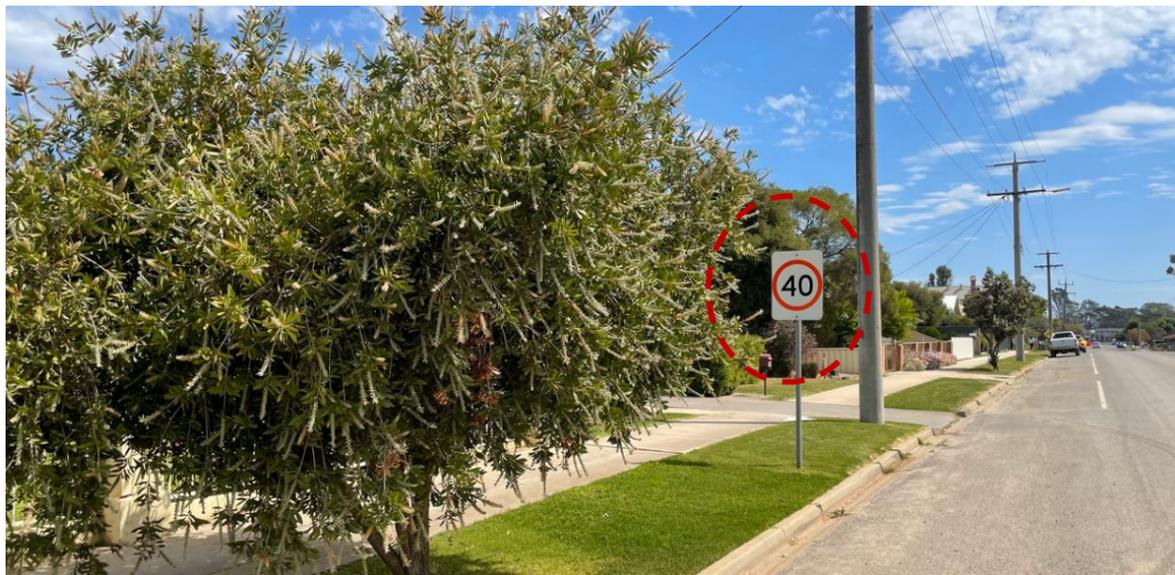
4 The 40km/h speed limit sign installed on the eastern approach of the crossing was observed to be obscured by a large tree as shown by the following three images.

Likelihood: Unlikely
Severity: Serious

Above Tolerable Limits

HIGH (FSI)

The second 40km/h speed limit sign is also found right at the crossing which does not allow sufficient time for drivers to process the information and to reduce the speed. Achieving reduced vehicular speeds is essential to a safe operation of the school crossing as;

- Drivers known to be more alert at reduced vehicular speeds; and
- Should a crash occur, the severity of the crash is lesser at the reduced vehicular speeds due to a reduced energy transfer.

The speed limit sign under discussion should be moved to

a location with better visibility
as a matter of urgency (P).

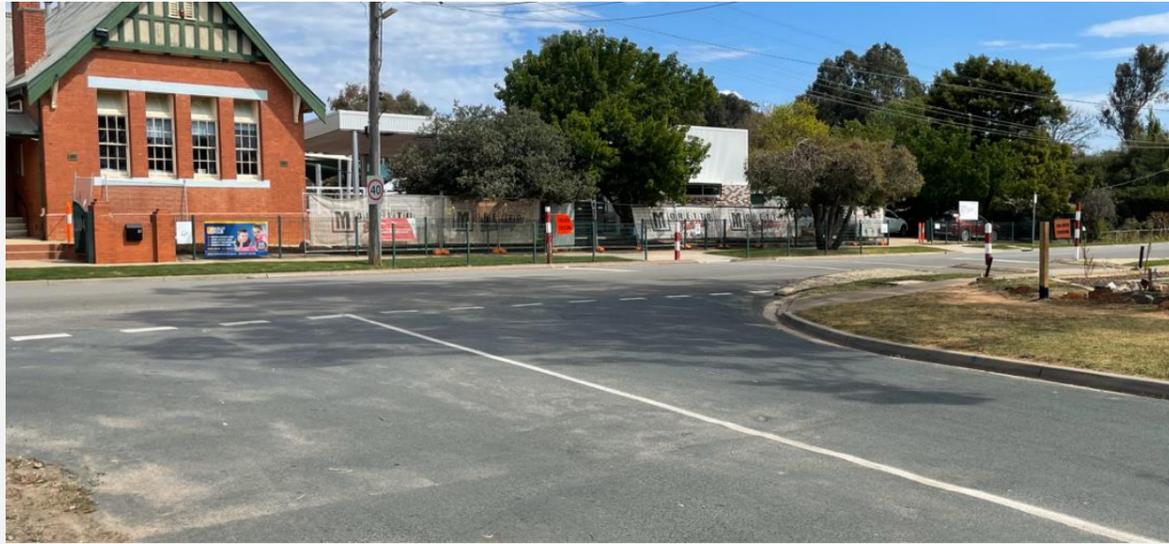
5 It is acknowledged that most vehicles exiting Boyd Street are vehicles associated with residencies in this street and tend to familiar with local conditions. Nonetheless, at any T-intersection drivers are required to process a large amount information and make quick decisions. The placement of the crossing with respect to the stop-line on Boyd Street adds to the complexity. This is because vehicles are required to not give-way to vehicles on Goulburn Street but also to follow the instructions of the crossing supervisor and come to a complete stop having just turned out of Boyd Street.

Sightlines were observed to be adequate, yet the crossing being located on the departure end of this operation means that vehicles exiting Boyd Street are “accelerating” as they approach the crossing. If a misjudgement is to occur, coming to a sudden stop is a challenging task with minimal braking distance between the point of conflict and the stop-line of Boyd Street.

Likelihood: Unlikely Severity: Moderate Medium	Above Tolerable Limits	Consider installing warning signs or similar on the southern side of Goulburn Street to indicate the presence of the children’s crossing (S).
---	------------------------	---

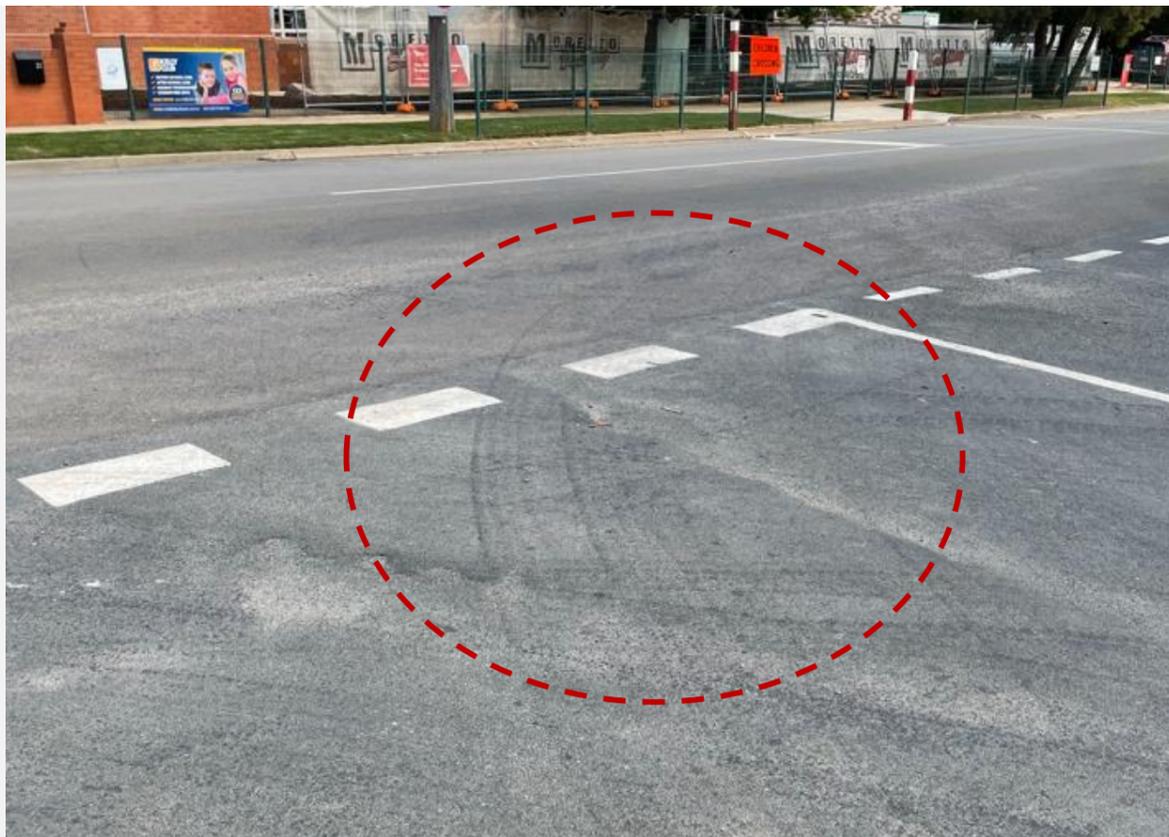
Tyre marks observed on the road pavement further indicates that the typical movement undertaken from Boyd Street does not allow for a vehicle to store fully within the traffic lane (behind the stop line) at the crossing which further exacerbates the conditions explained above.
