APPENDIX A. CONDITION ASSESSMENT

Condition Assessment

Chinamans Bridge, Nagambie

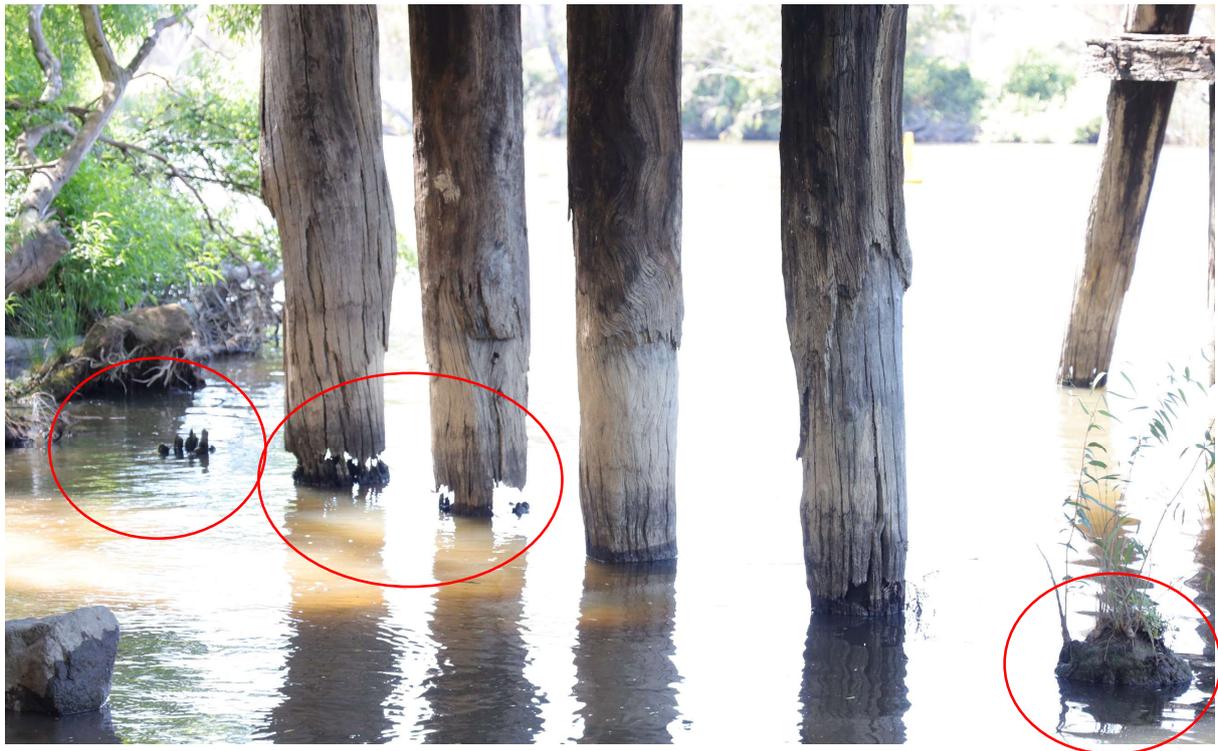
Approximately 80% of piles are deteriorated at the base from continual wetting and drying causing accelerated deterioration. Of these at least half are completely rotten through at the base and provide no structural support to the structure above it.

In addition, approx. 10% piles are completely missing. It is estimated that only 10% of all piles are structurally sound.

Image: View of piles in the northern-most bent showing two completely rotten through and two piles completely missing. Source: Thomas Cohen.

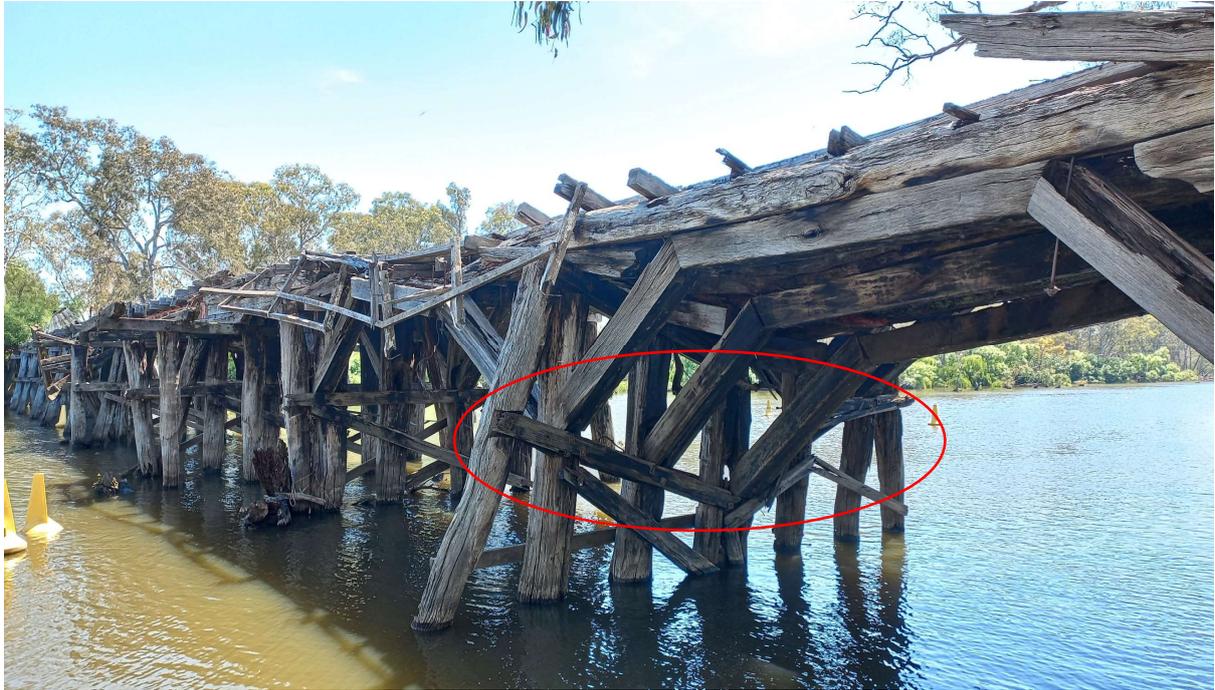
Sills have rotted through at most ends resulting in the outer connections to the batter-posts coming loose. The sills have collapsed at the southern end.

Image: Collapsed sill at southern end of bridge resulting in collapse of bracing connected to it. Source: Mim Butcher.

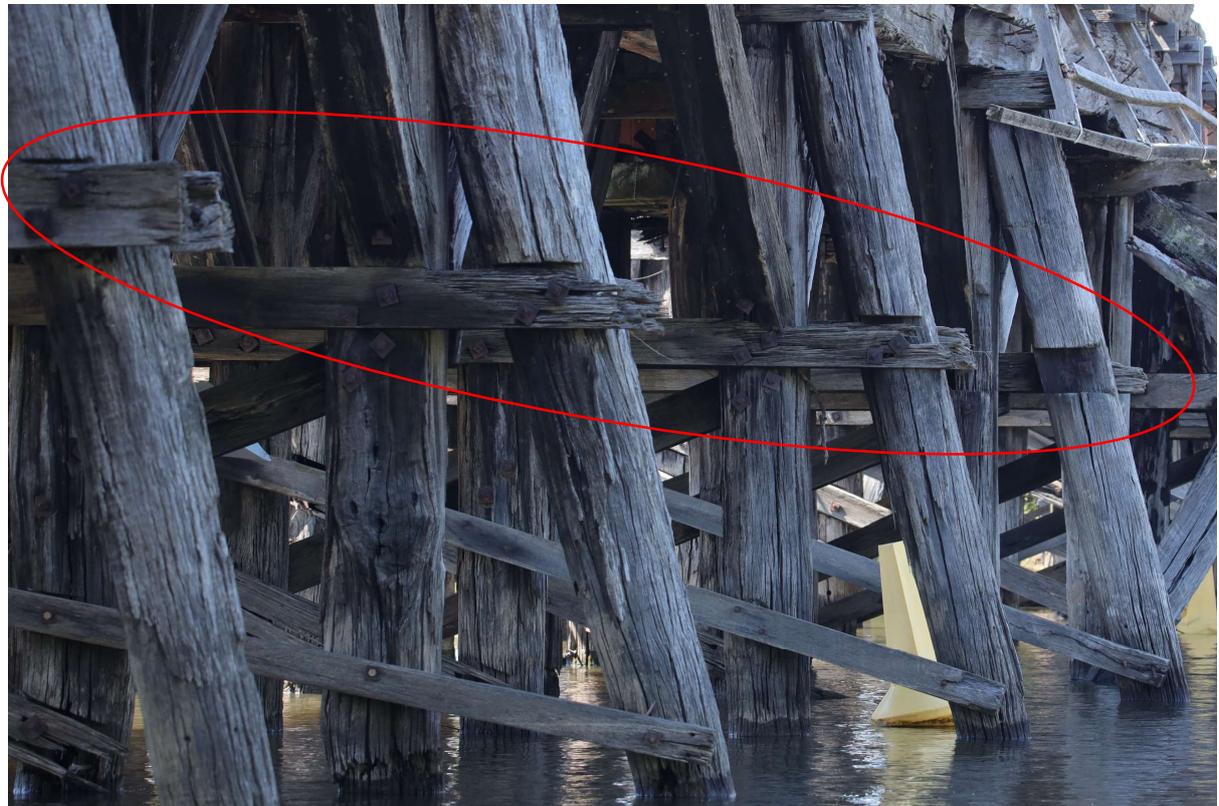
Image: Rotten ends of sill timbers. Source: Thomas Cohen.

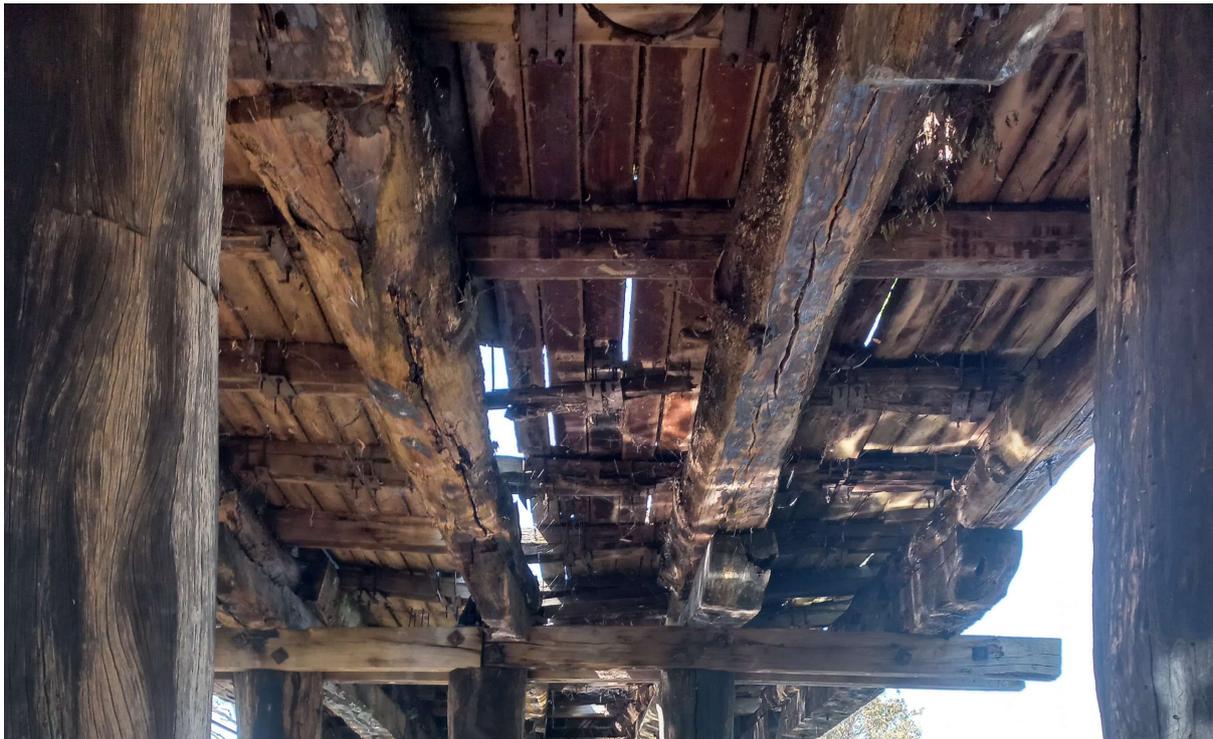
Girders and corbels appear to be in reasonable condition. Many have cracking running lengthways, occurring as they dried out over time (they would have been green timbers when installed). There is some termite damage to these timbers at the northern end of the bridge.

Image: Underside of bridge at northern end with two girders/stringers at centre. Note the natural cracking from drying process. Source: Mim Butcher.

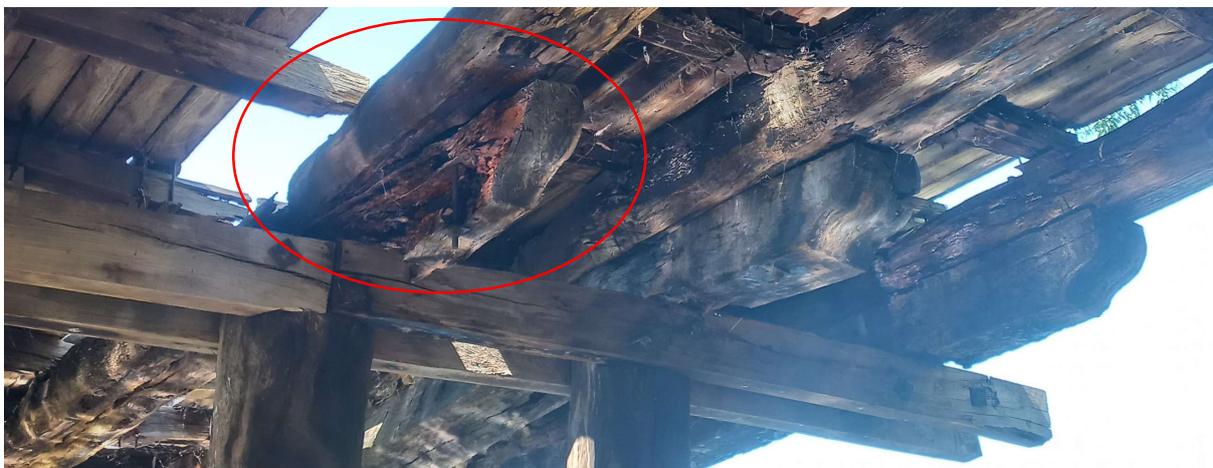
Image: Termite damaged corbel. Source: Mim Butcher.

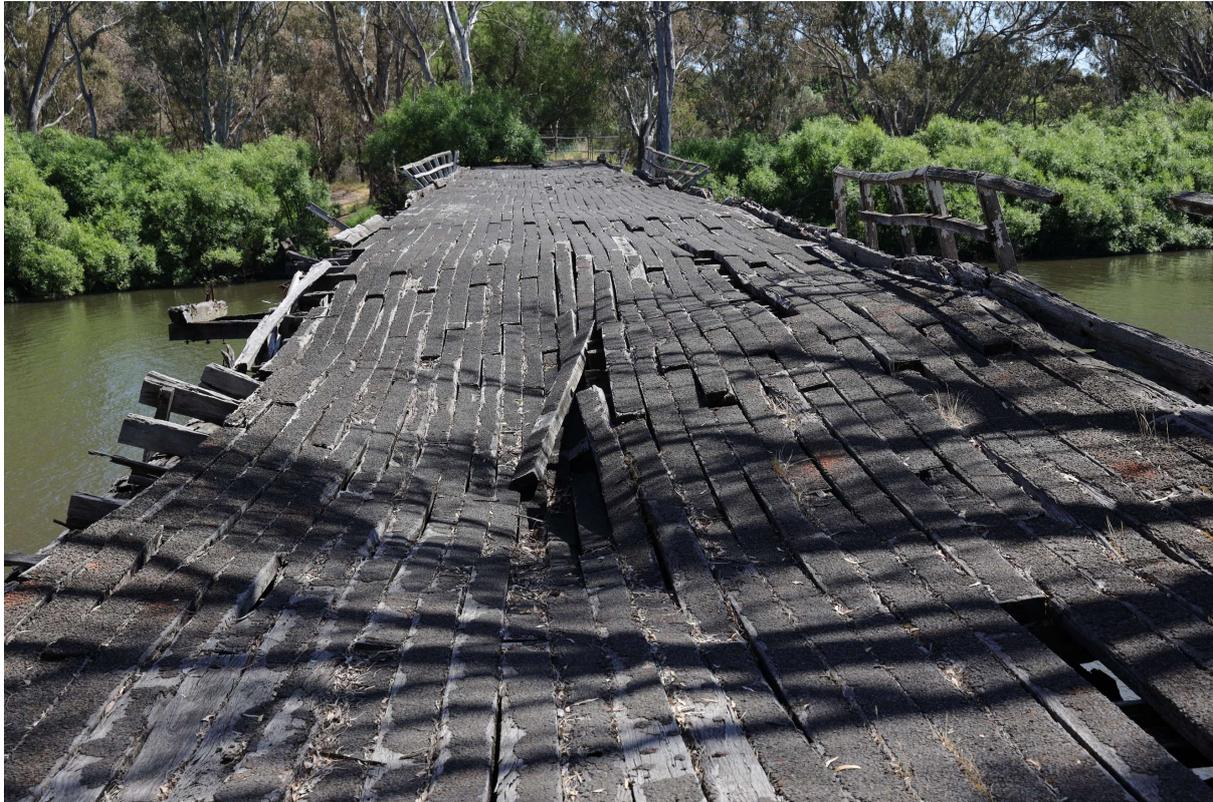
The bridge deck has deteriorated beyond repair. It has caved in at the southern end due to collapse of the timber structure below. Handrails which ran along the perimeter have fallen off.

Image: The bridge deck from the southern end looking north. Source: Thomas Cohen.

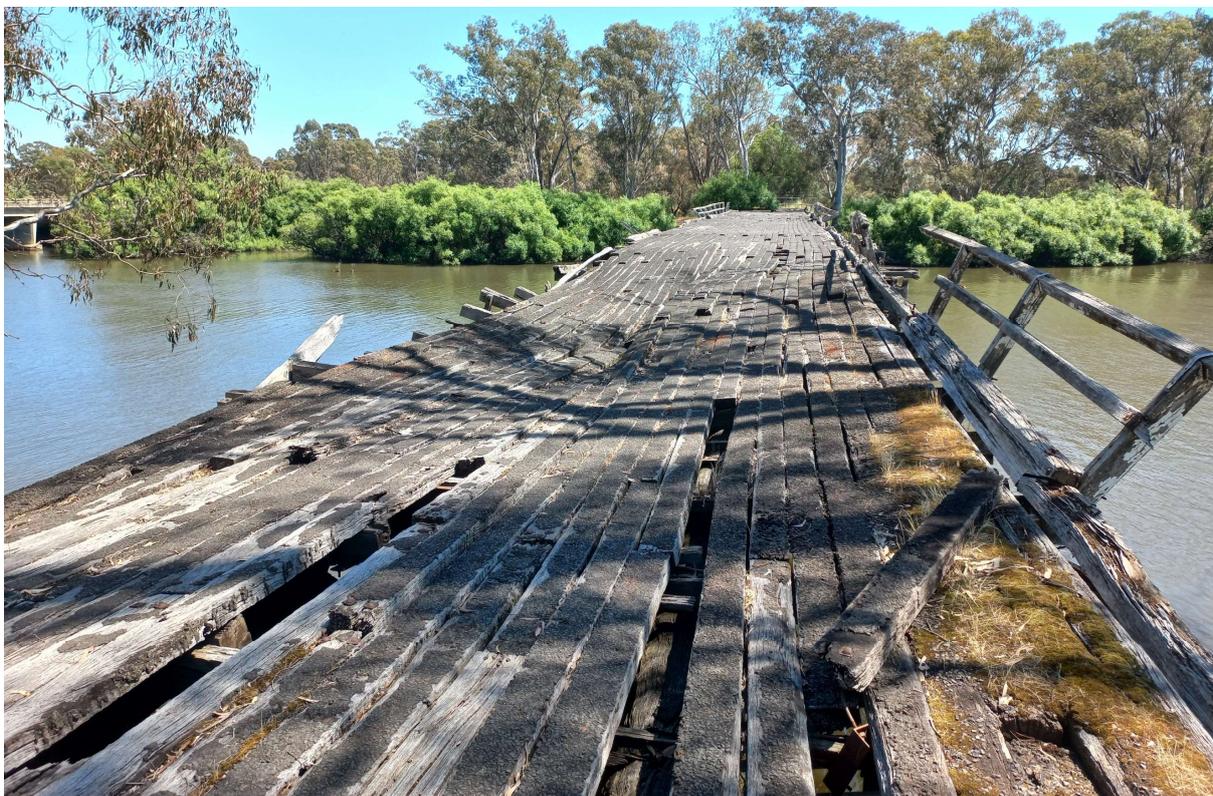
Image: The bridge deck from the northern end looking south. Source: Mim Butcher.

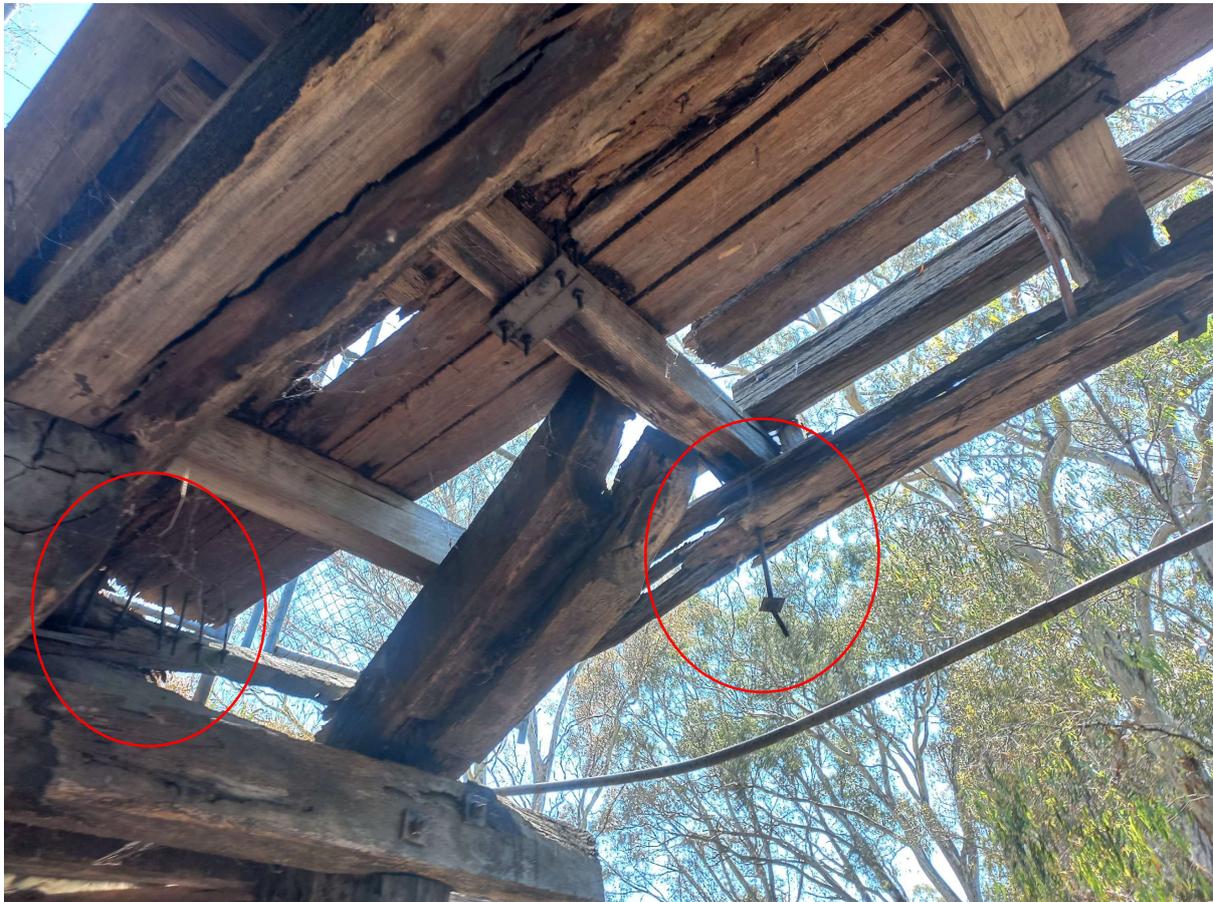
Generally, the metal fixings (assumed to be wrought iron) which tie the bridge timbers together have come loose across the length of the bridge as the timber members have deteriorated.

Image: Loose connections between cross-ties and deck. Source: Mim Butcher.
