GREENING EUROA – STAGE 1

REPORT

OCTOBER 2020

FORESIGHT ADVISORY

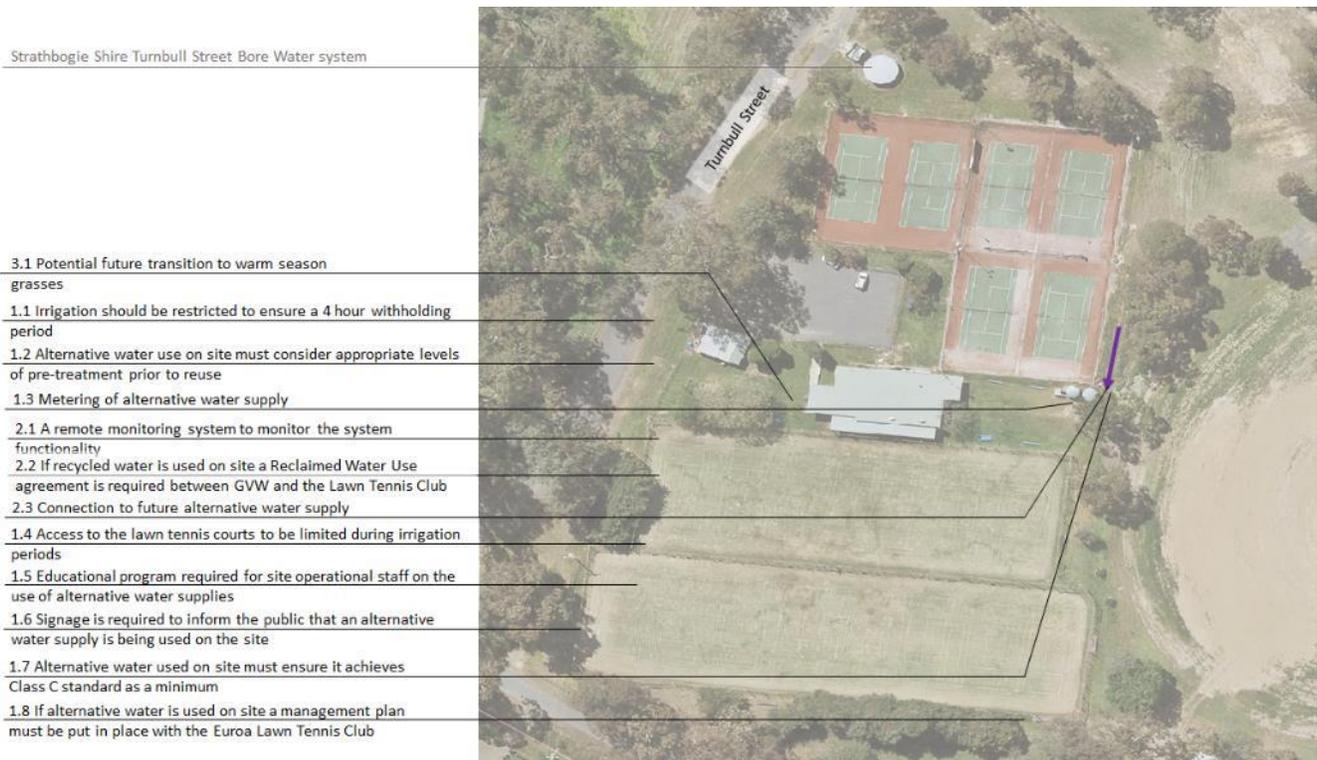
Figure 45 – Euroa Lawn Tennis Club Facility Design

- The existing infrastructure on the site is functional with some elements nearing 10 years of age. Given the age of the system it is subject to water losses associated with leakages
- There are no evaporative losses from the storages on site which are all above ground tanks
- The existing 60,000L storage tank (2 x No. 30,000L Plastic Tanks) provides sufficient water storage for one irrigation cycle during peak demand periods. This storage size is adequate to cater for the current irrigation demands and a future connection to an alternative water supply
- An automated irrigation system on the site allows for controlled irrigation of the courts, using preprogrammed stations
- The tennis courts have a 3m high chain link fence around its perimeter that can be locked.

- 3.1 The introduction of warm season grasses on the Euroa Lawn Tennis Courts could reduce water consumption by greater than 10%.

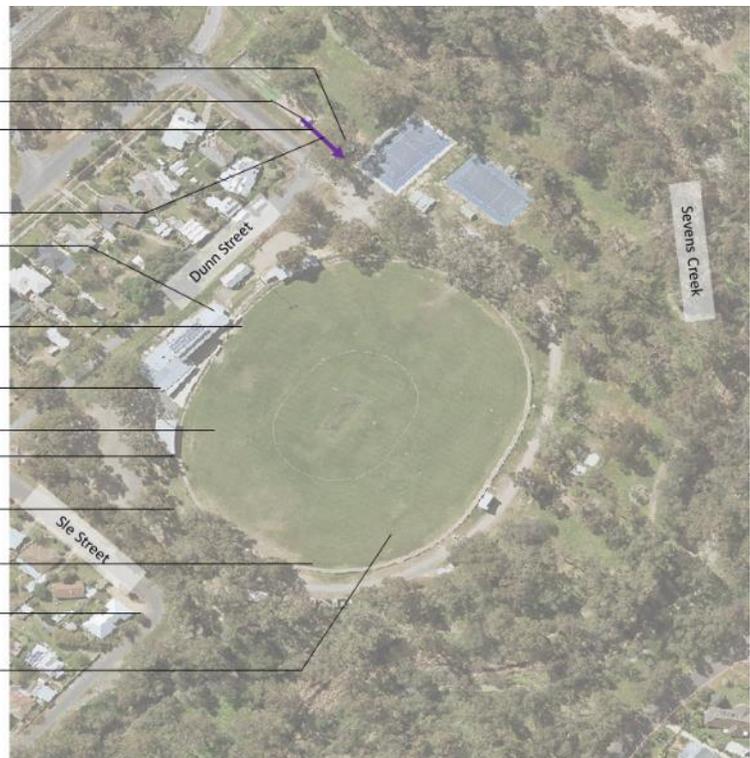
Figure 47 – Memorial Oval Facility Design

- The storages on site are insufficient to meet the current irrigation demands and can not cater for a future connection to an alternative water supply
- Given the age of the irrigation infrastructure it is currently in need of an upgrade due to leaks and lack of effective coverage from the Oval's sprinklers
- An automated irrigation system on the site allows for controlled irrigation of the courts, using preprogrammed stations
- Memorial Oval has a 1.5m high chain link fence around the playing area which can be locked during irrigation cycles.

- 1.7 Upgrade irrigation system on Memorial Oval
- 3.1 Potential future transition to warm season grasses
- 1.9 If alternative water is used on site a management plan must be put in place with the Memorial Oval Committee of Management

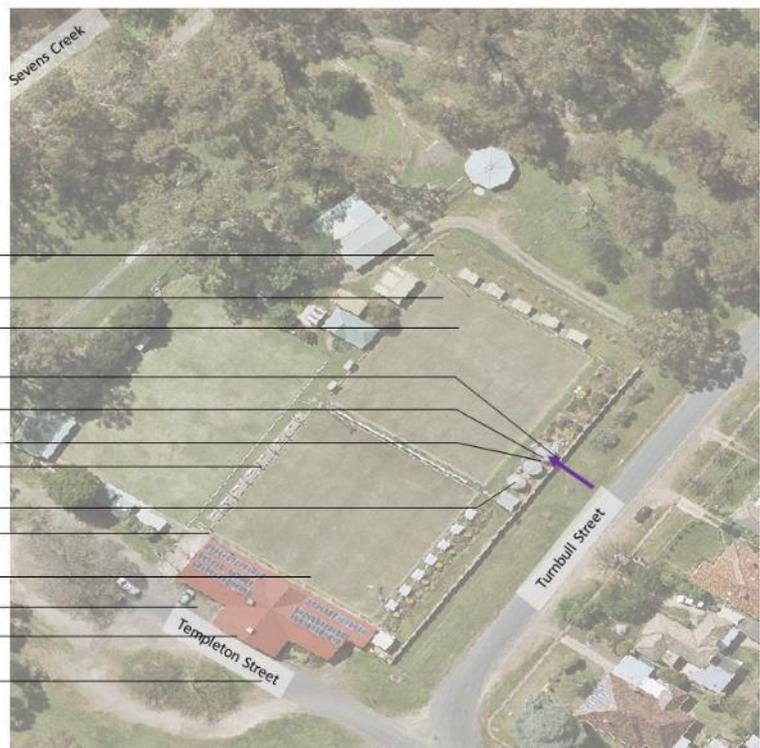
Figure 49 – Euroa Lawn Bowls Facility Design

- Based on water quality sampling of this raw water source, it does not meet Class D recycled water standards. This risk should be noted given a recycled water of this quality is not suitable for irrigation of municipal public open space (EPA, 2003)

- 1.8 Replace existing concrete tank
- 1.4 Access to the irrigated area during watering must be restricted. Lockable gates and potential separation / coordination of irrigation with the Croquet Club

- 1.3 Irrigation should be restricted to ensure a 4 hour withholding period
- 1.2 Installation of an automated irrigation system for the site
- 1.1 Educational program required for site operational staff on the use of alternative water supplies

- 1.5 Signage is required to inform the public that an alternative water supply is being used on the site

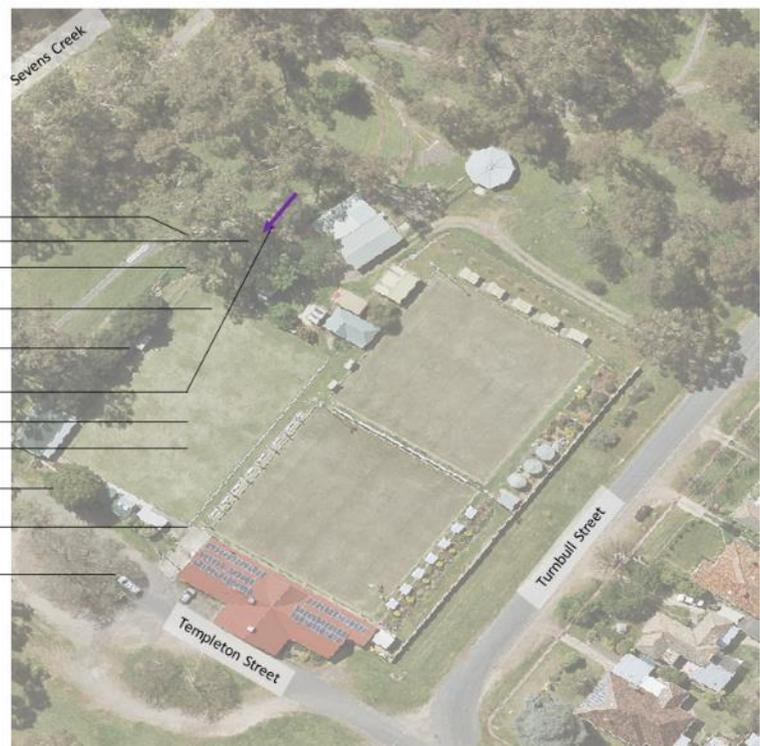
Figure 51 - Euroa Croquet Club Facility Design

- Based on water quality sampling of this raw water source, it does not meet Class D recycled water standards. This risk should be noted given a recycled water of this quality is not suitable for irrigation of municipal public open space (EPA, 2003)

- 1.2 Irrigation should be restricted to ensure a 4 hour withholding period
- 1.3 Access to the irrigated area during watering must be restricted. Lockable gates and potential separation / coordination of irrigation with the Bowls Club

- 1.4 Signage is required to inform the public that an alternative water supply is being used on the site
