STRATHBOGIE SHIRE COUNCIL

12.2.1 Tree Management – Seven Creeks Park, Euroa Township

***Eucalyptus camaldulensis* (River Red Gum)
Apex Park, Euroa Victoria**

**Visual Tree Inspection Report
for the
Shire of Strathbogie, Victoria,
Australia**

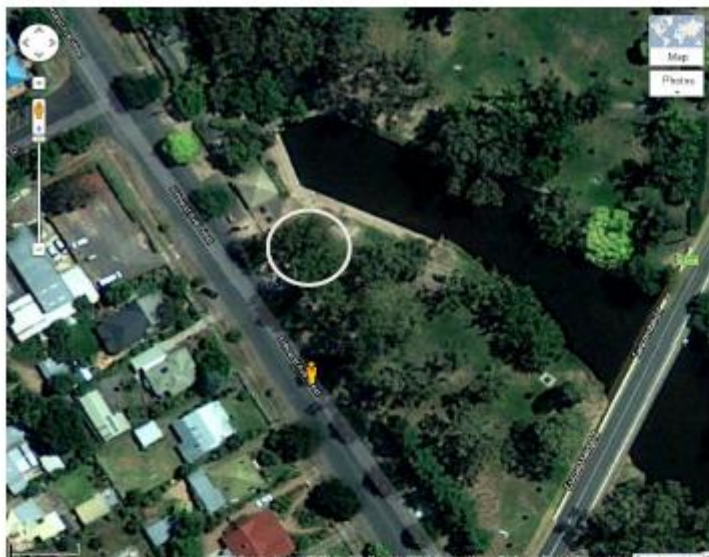
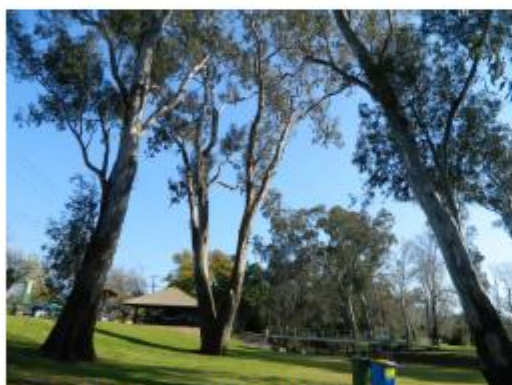
Tree at location

Tree at location the tree looking from the east

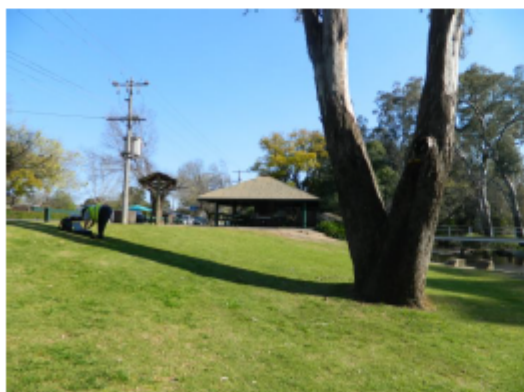
No surface roots where seen and a sub surface inspection was not warranted.

Base of the tree

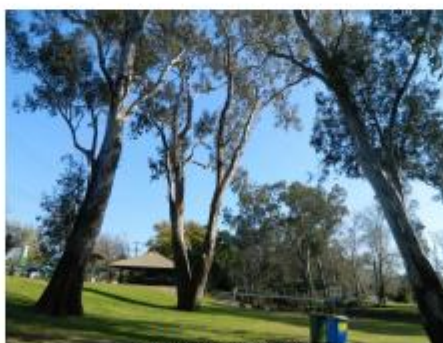
View of Apex Park

The area has a large high canopy which should remain. Within this area there are two trees which have been recommended for removal (refer to spreadsheet and a copy of the attached report for the large western tree close to the footbridge).

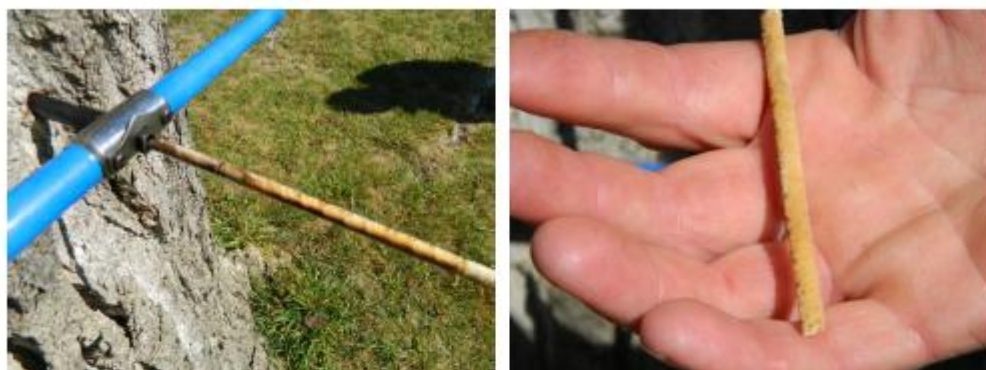
A number of the *Populus alba* were drilled and they were found to be hollow. The TR Ratio (see footnotes) was poor and the trees are in decline. One tree in particular was found to be almost completely hollow and was removed. A number of trees were tested with a sounding hammer in front of Council staff as well as an elected member, it was confirmed in front of them that the trees had hollows and are in decline.

A sample being from a *Populus* sp. taken with a decoerer.

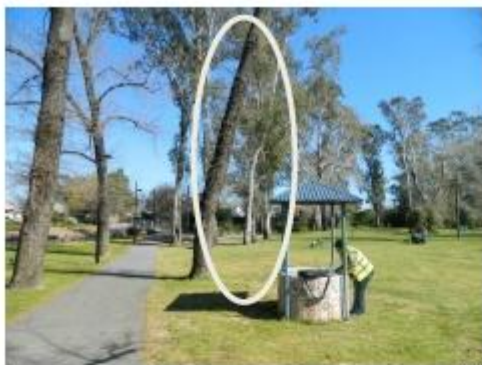
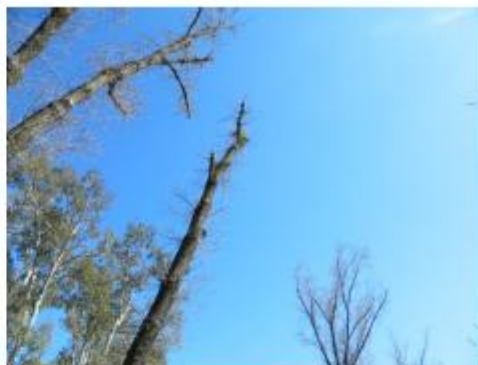
E00112

Trees to be removed in Area Two

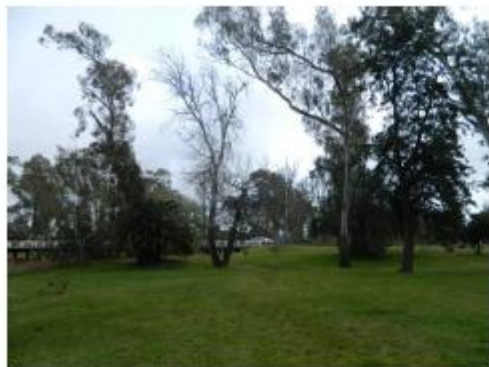
E00191

Trees to be removed from Area 4

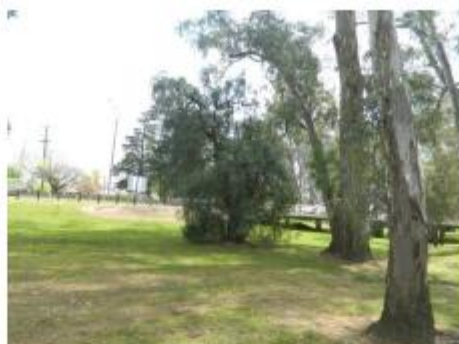
E251

Trees to be removed in Area Five

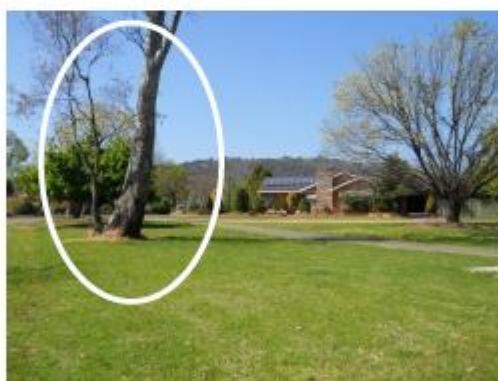
This site is south of the Bowling Club and may be used in the future for a circus, at this time we would suggest that the trees be pruned or removed before this occurs, within the area are a number of *Eucalyptus camaldulensis* (River Red Gum) which are in decline. One large tree E289 which is dead for no reason (no reason for the decline was noted or found). It is a shame, as this tree has good vigour and form.

Trees to be Removed from Area Six

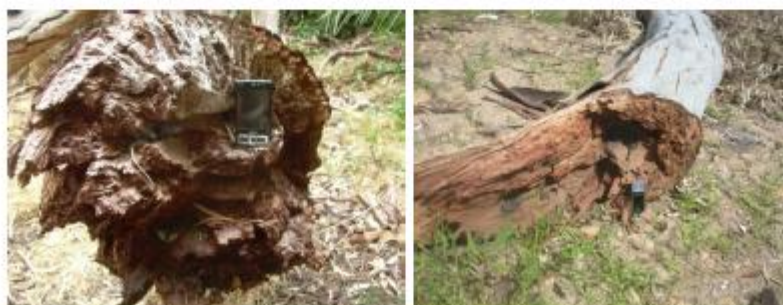
Sudden Limb Failure (SLF) is a common problem for many species of trees including exotic trees; it almost always affects limbs held in a horizontal or near horizontal plane; though more upright limbs have also been known to fail due to SLF. Defects do not have to be present; however, if wounds or decay are present the risk of SLF is usually exacerbated.

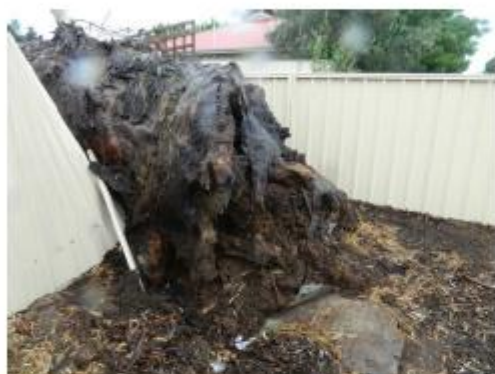
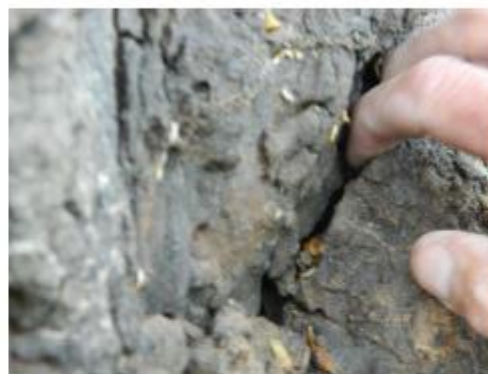
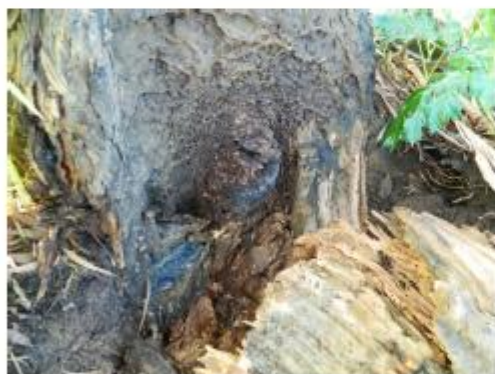
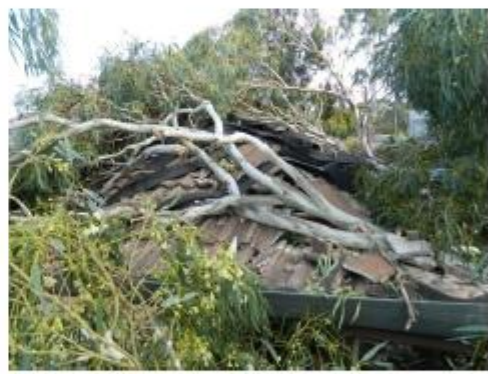
Lions tail/end loading

The scaffolding branches have been extremely poorly maintained in the past and incorrect pruned with has lions tailed the branches end loading. This problem of end loading seems to be particularly serious, “if it has been brought about by the removal of middle and lower branches”, (Dr David Lonsdale).

Thinning, like reduction, can have undesirable effects when carried out badly or to excess. Excessive opening up of the crown structure can expose individual branches or more to increased

wind penetration and turbulence, so increasing the chance of their breakage which has occurred to this tree.

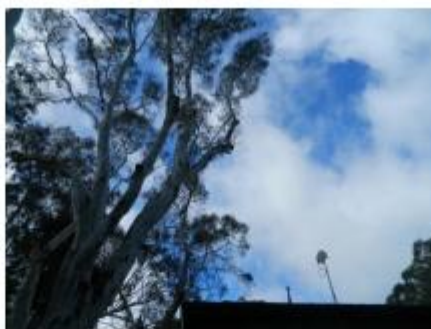
Asymmetrical Wind Loading

Asymmetrical wind loading “slowly twists the branches around the observed direction, this in turn can put strain and stress onto this part of the tree” (Larry Gedney, University of Alaska)

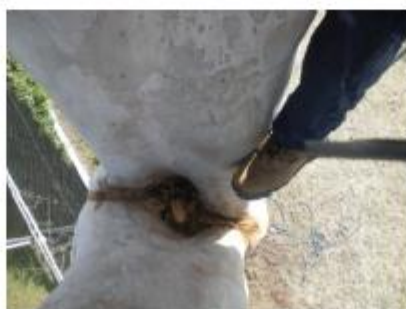
Girdling Roots

A root is described as girdling if it crosses over the base of a major root. This type of root's growth is constricted as a consequence and failure can occur at the point of girdling due to the mechanical stress concentrated in that area.

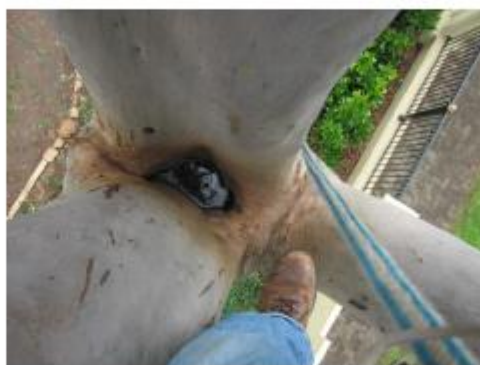
Kino is a red resin and is a natural defence mechanism against pathogen attack in most trees. If the tree is under stress and does not have sufficient Kino then pathogens can enter the tree causing possible catastrophic effect on the tree's life.

Once a tree is under stress then it is very prone to borer attack. Most trees have a natural defence mechanism against borers, for example: Gum trees produce a red substance called Kino, wattles produce gum, Figs produce latex (that is the milky white fluid that we see in rubber trees and other fig type plants) and Pines produce resin. Kino, gum, latex and resin are the four most common natural defence mechanisms in trees.

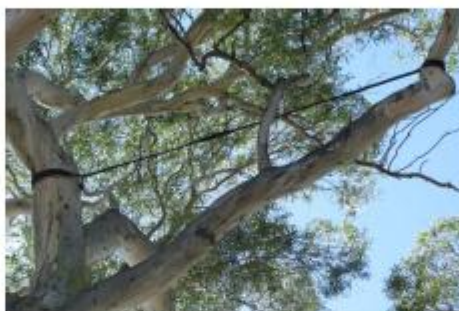
Cobra

Cable, bracing or cobra only shows admittance that the tree is at fault. If the tree were to be braced correctly, two to three scaffolding branches at the very least would need to be braced. However, as pointed out in this report the scaffolding branches have weak attachments and bracing them may not be beneficial for the tree.

Following extensive analysis and careful consideration, it is our professional opinion that the trees should be removed and pruned and inspected ever two years or after major storms or floods or failure.

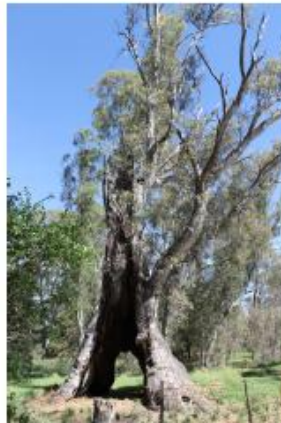
Plate 2: Tree vertical perspective.

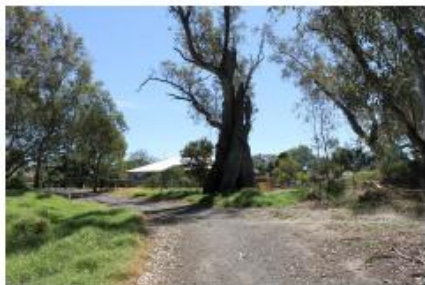
The remaining crown presents with a significantly modified canopy and is also predisposed to potential limb failure. These can be induced by either storm or strong wind events. The consequences of limb or crown failure will target the path or the road in close proximity on the west sector.

Plate 3: Tree and proximity to gravel path ▲.

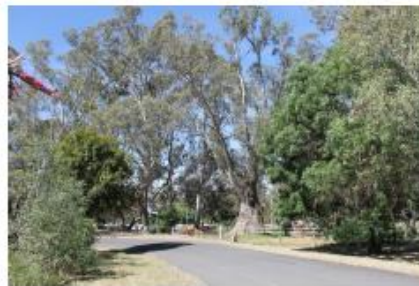
The tree has immense cultural significance, however due to its condition presents as a hazard tree. The majority of defects have been present for an extended period of time. The specimen is in decline. Target opportunity for the remaining branches and bulk of the live sections would be the path that is adjacent to the tree. A major limb overhangs the road on the west sector.

Plate 4: Tree relative to road in proximity to standing Eucalypts ►.

Hazard abatement would require that the part of the tree that presents as failure potential be removed to a sound framework.
