GREENING EUROA – STAGE 1

REPORT

OCTOBER 2020

FORESIGHT ADVISORY

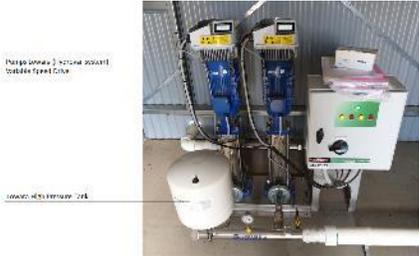
Figure 7– Pumps, Filter and Pressure Tank

- 100,000L Rhino Galvanised Steel Tank (Dark Green) – Holding capacity approximately 80,000L (Figure 5)
- Pop-up sprinkler irrigation system (Figure 6)
- Pump shed housing:
 - Pumps Lowara (Hydrovar system) – Variable Speed Drive (Figure 7)
 - Lowara High Pressure Tank (Figure 7)
 - Automated Irrigation System (Hunter Irrigation Controller) (Figure 8)
 - Irrigation Filter (Dix Engineering) (Figure 9)
- The oval has a 1.5m high picket fence around its perimeter which can be locked
- Grass used on the oval is not a drought tolerant species.

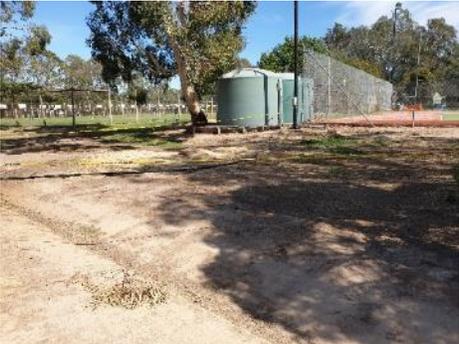
Figure 11 – 2No. 30,000L Plastic Tanks

- 2 x No. 30,000L Plastic Tanks (Green) (Figure 11)
- Pump Shed housing:
 - Irrigation Pump (Details unknown)
- Automated Irrigation System (Irritrol – Total Control Unit) (Figure 12)
- Connection to the Strathbogie Shire Council Turnbull Street Public Groundwater system
- The tennis courts have a 3m high chain link fence around its perimeter that can be locked
- Grass used on the tennis courts is not a drought tolerant species.

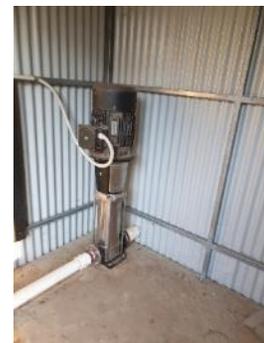
Figure 15– Irrigation Pump

- 1No 15,000L Plastic Tank (Black) (Figure 13)
- 1No. 19,000L Galvanised Steel Tank (Figure 13)
- Pop-up sprinkler irrigation system (Figure 14)
- Pump shed housing:
 - Grunfos Vertical Multistage pump (Figure 15)
 - Irrigation Filter (Dix Engineering) (Figure 16)
- Automated Irrigation System (Hunter XCore Irrigation Controller) (Figure 17)
- Pump connection to the Sevens Creek – this is under a current Water Right owned by Council
- 4No. potable water connection points for watering the wicket area
- The oval has a 1.5m high chain link fence around its perimeter that can be locked (Figure 18)
- The grass on the oval is not a drought tolerant species

The storages on site are insufficient to meet the current irrigation demands. It is also noted that given the age of the irrigation system it is currently in need of an upgrade.
