Goulburn Street School Crossing Existing Conditions Road Safety Audit

Prepared for Strathbogie Shire Council

10 September 2023

Reference J388O530/0923

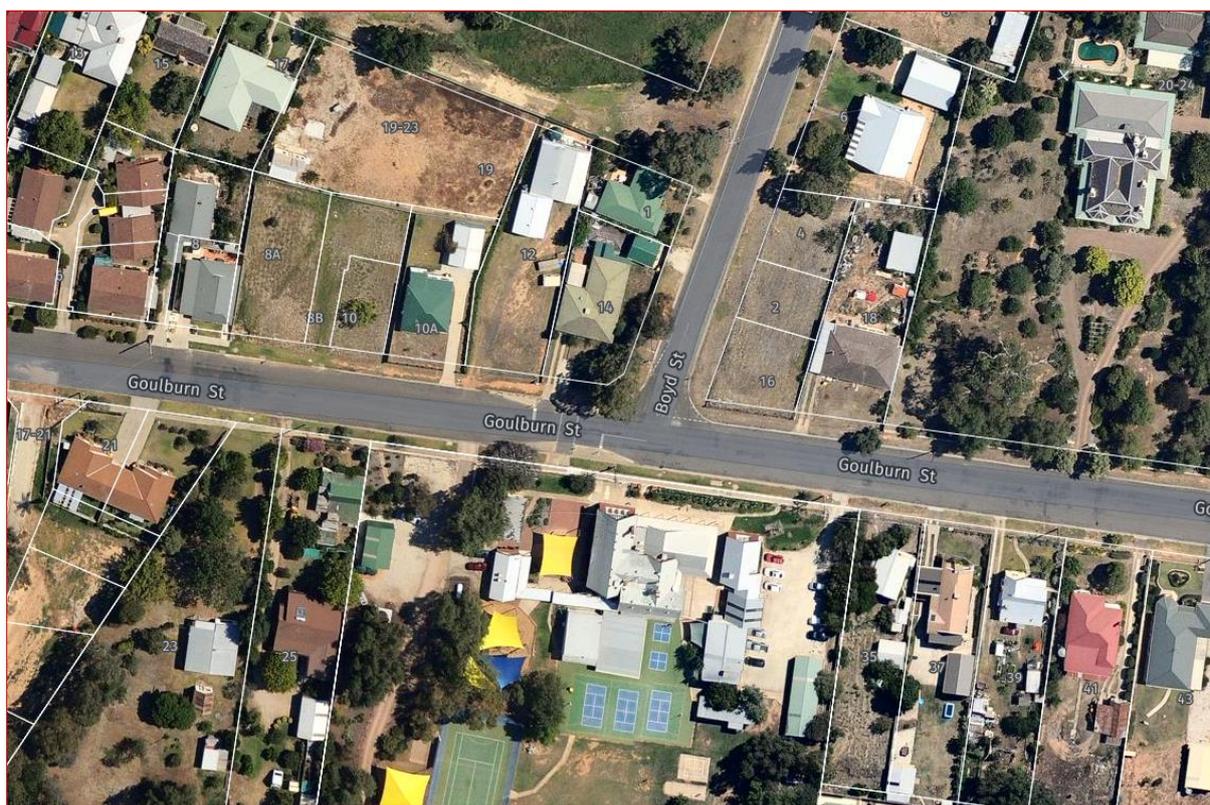
FIGURE 1: SUBJECT SITE (SOURCE: NEARMAP)

Subject Site of this Road Safety Audit includes a school crossing (*i.e.* children's crossing) located on Goulburn Street in Nagambie, Victoria. The crossing is found on Goulburn Street approximately 340m east of High Street and immediately west of Boyd Street and facilitates pedestrian movements to and from Nagambie Primary School.

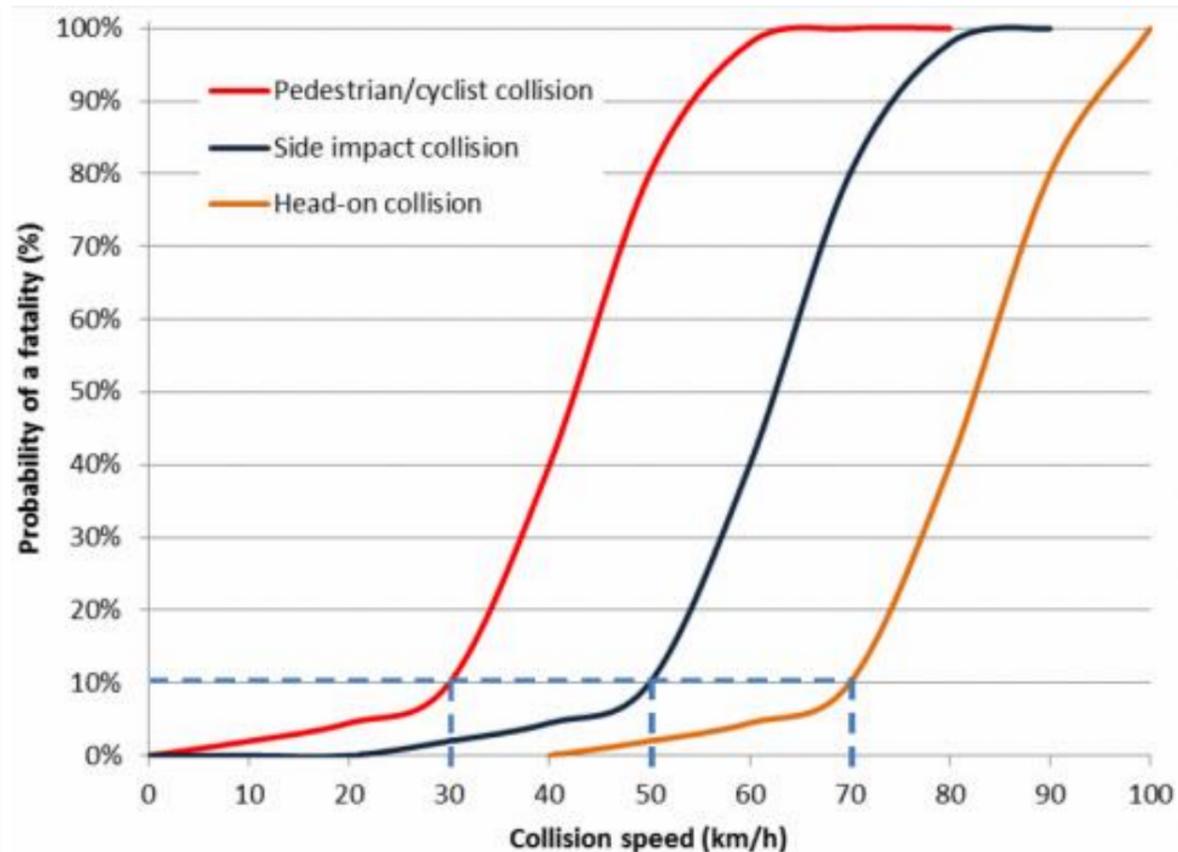
It is said “the human body is vulnerable not built to withstand impact forces greater than 30km/h – any impact greater than 30km/h greatly increases the risk of dying”.

Consider reducing the speed limit to 30km/h or lower (P).
 Consider implementing LATM devices to reduce vehicular speeds (P).

Considering these factors, RedSquare Traffic recommends lowering the speed limit in accordance with the Safe System Framework, to 30km/h or less on the approach to the crossing to reduce the “severity of collisions”, should a collision is to take place. It is beneficial if such a posted speed limit is supplemented by Local Area Traffic Management (LATM) treatments that would reduce the driver speeds through speed limiting devices (e.g. road humps, rumble strips) rather than relying on drivers to comply with regulatory speed limits.
